150041 – Shannock Valley Elementary

150041; Shannock Valley Elementary School. This school is located off of School Street W., Rural Valley, Pennsylvania in Rural Valley Borough, Armstrong County. It is part of the Armstrong School District. The 1963 school building is located at the end of a driveway off of School Street W. behind properties located along the main roadway. The elementary school is part of a complex that originally included a senior high school and separate gymnasium. These have been converted to a maintenance complex. A basketball court enclosed by fencing is located south of the maintenance complex. The elementary school is situated to the east of the maintenance complex, behind a circular driveway surrounding a grassy island with a flag pole and armed services memorial. South of the school building is a playground with a mix of 1960s and modern playground equipment. North of the school is a paved play area and, beyond, a football field with bleachers, a press box, and concession stand, and a baseball field. Maintenance garages that appear to date to the construction of the school are also located north of the school. East of the school is a two-tiered parking l

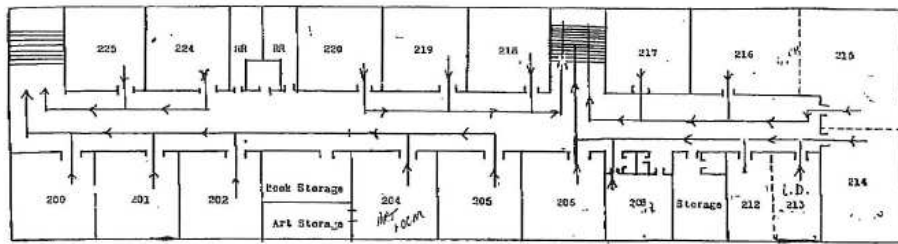
Building Evacuation Plan
Shannock Valley Elementary School

First Floor

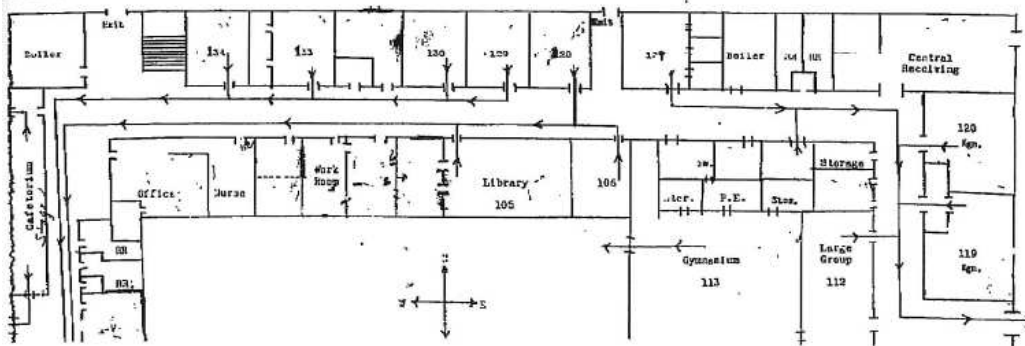
Floor Plan of Shannock Valley Elementary

The 1963 core of the school is a two-story structure arranged along linear interior hallways lined on either side by classrooms. A cafetorium is located at the west end of the school. A library is located towards the east end of the core. An addition, constructed ca. 1972-74, is appended to the east end of the school. Its construction materials and design are similar to the original structure. The structure has brick and porcelain enameled steel curtain walls. A flat roof is covered with rubber membrane. The building has a brick exterior chimney. The main entrance to the school contains a pair of metal-frame glass double doors surrounded by fixed windows. The entrance is sheltered by a steel overhang. The school is lit by picture and awning windows.
