Standards for Rehabilitation & Guidelines for Rehabilitating Historic Buildings

Standards for Rehabilitation

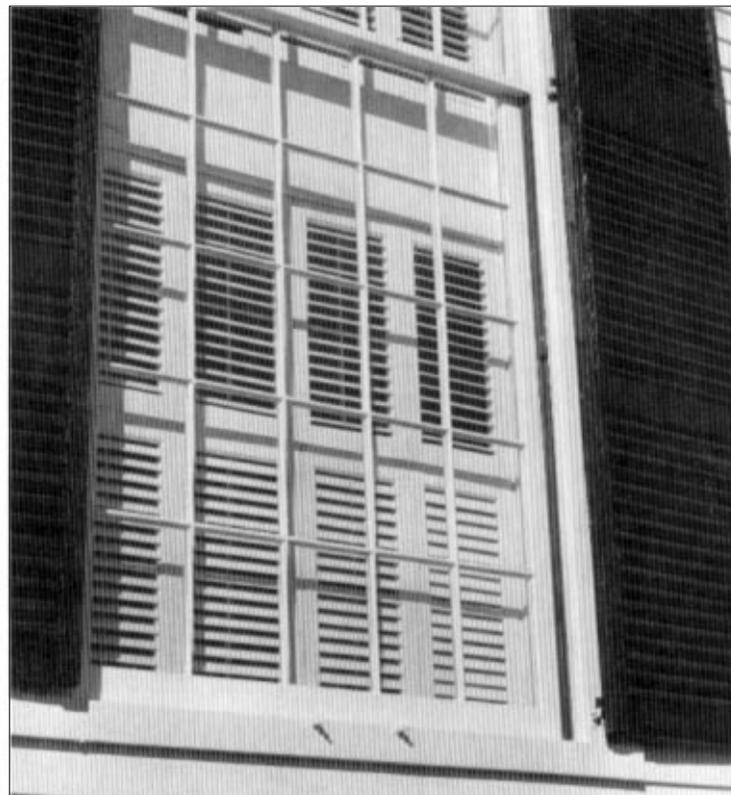
According to the Standards for Rehabilitation, existing historic materials should be protected, maintained and repaired. In an exemplary project, the windows and shutters of this historic residence were carefully preserved.

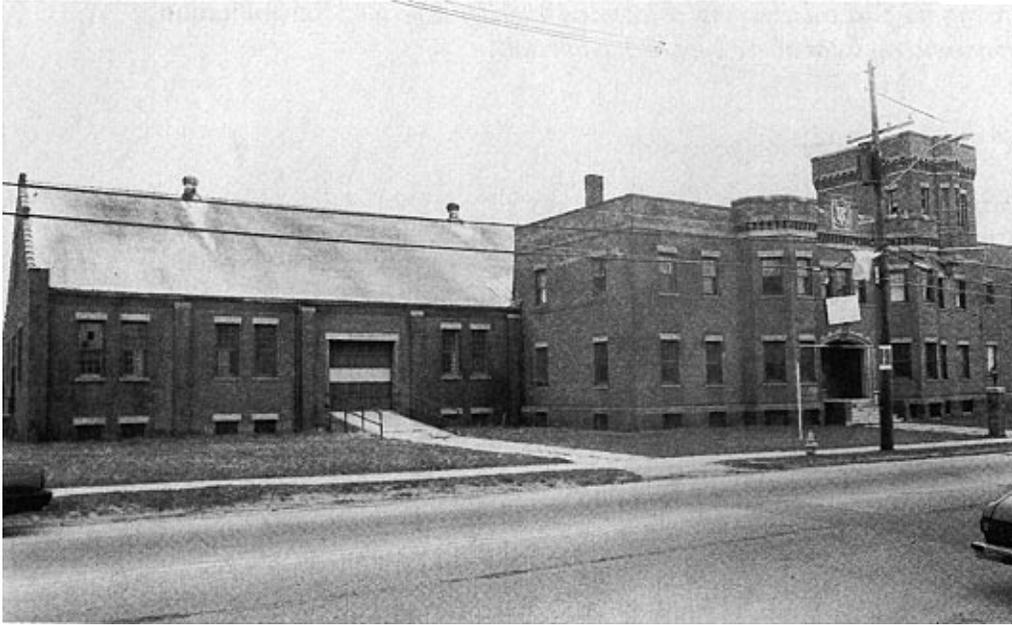
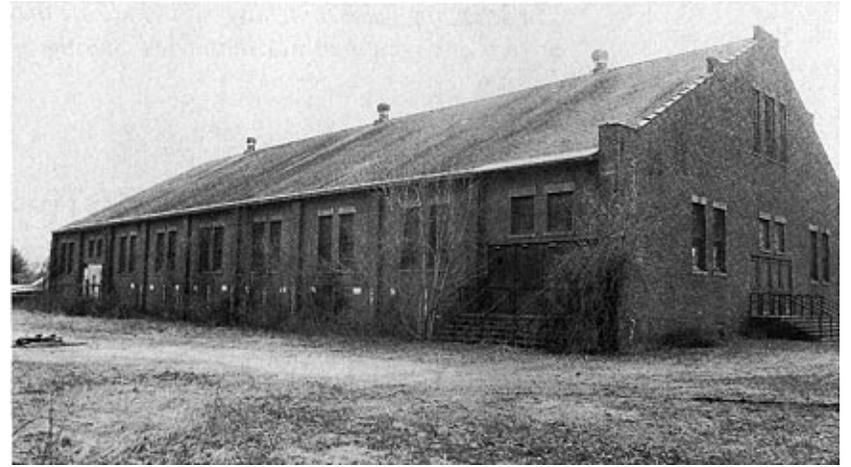
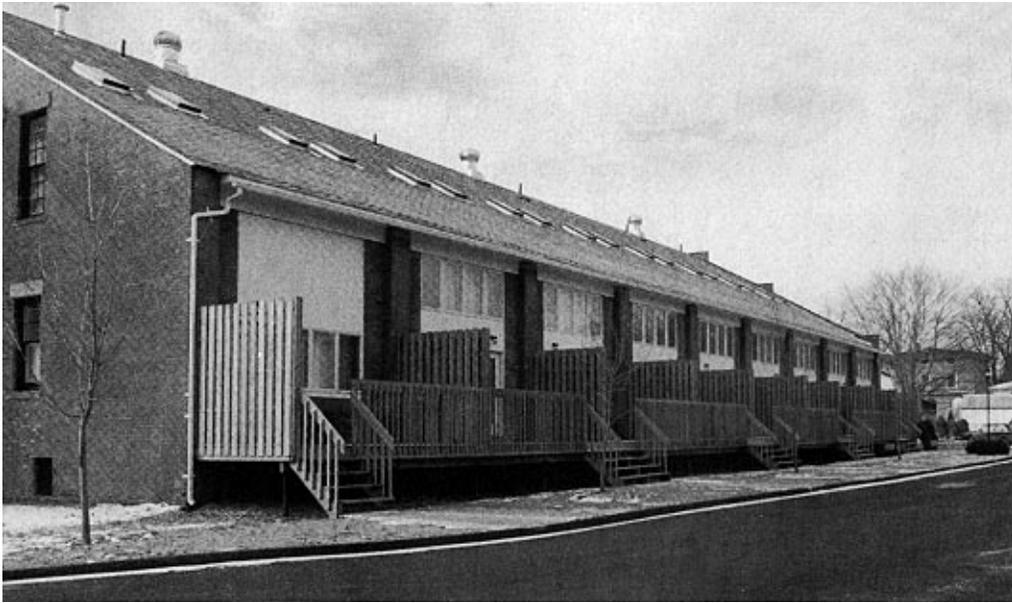
(a) An armory complex was rehabilitated for rental housing. (b) This view of the rear elevation shows the paired, nine-over-nine wood sash windows and high sills that characterized the building. (c) After inappropriate rehabilitation work, the same rear elevation is shown with new skylights added to the roof, prefabricated panels filling the former brick areas, and new wood decks and privacy fences. Because the work changed the historic character, the project did not meet the Standards.

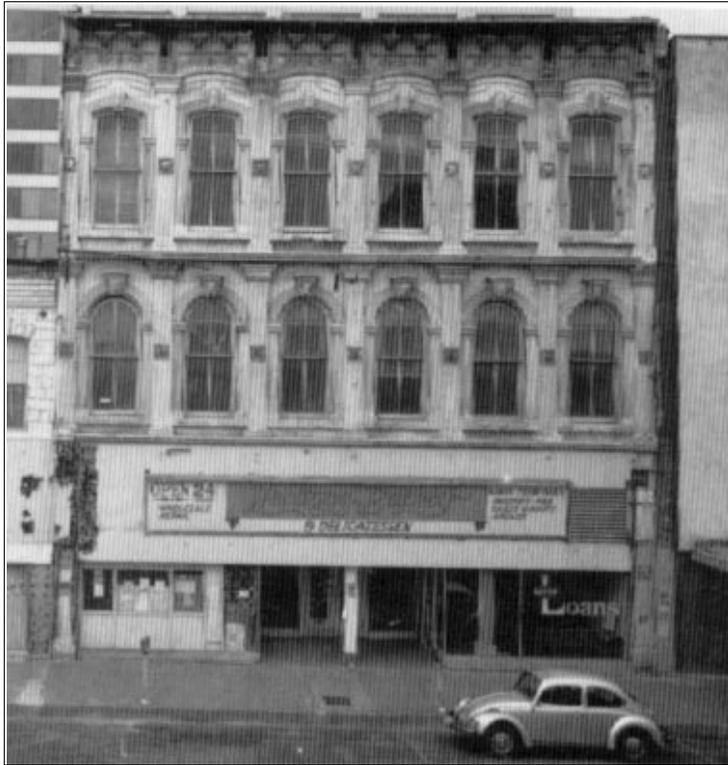
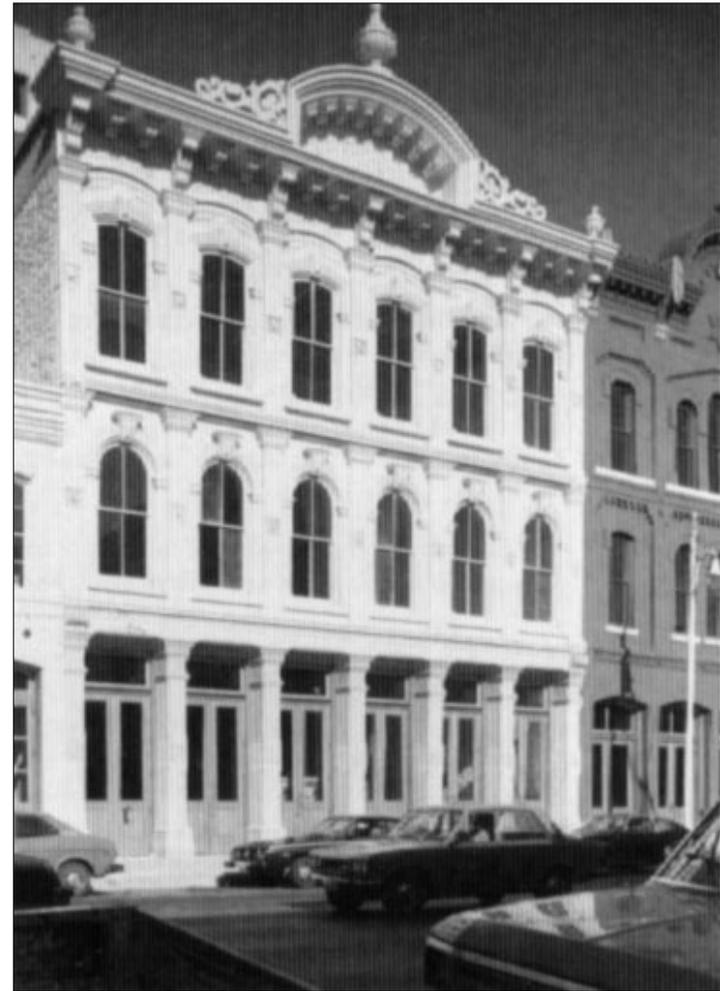
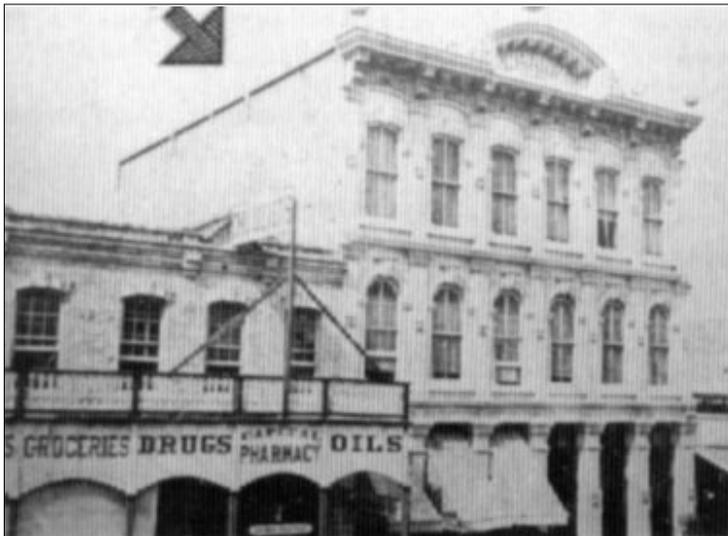
In the treatment, Rehabilitation, one option for replacing missing historic features is to use pictorial documentation and/or physical evidence to re-create the historic feature. (a) In this example, the ornamental cornice of an 1866 limestone building was missing; and the ground level storefront had been extensively altered. (b) and (c) Based on the availability of photographic and other documentation, the owners were able to accurately restore the cornice and storefront to their historic configuration. A substitute material, fiberglass, was used to fabricate the missing pressed metal cornice, an acceptable alternative in this project. All work met the Standards.

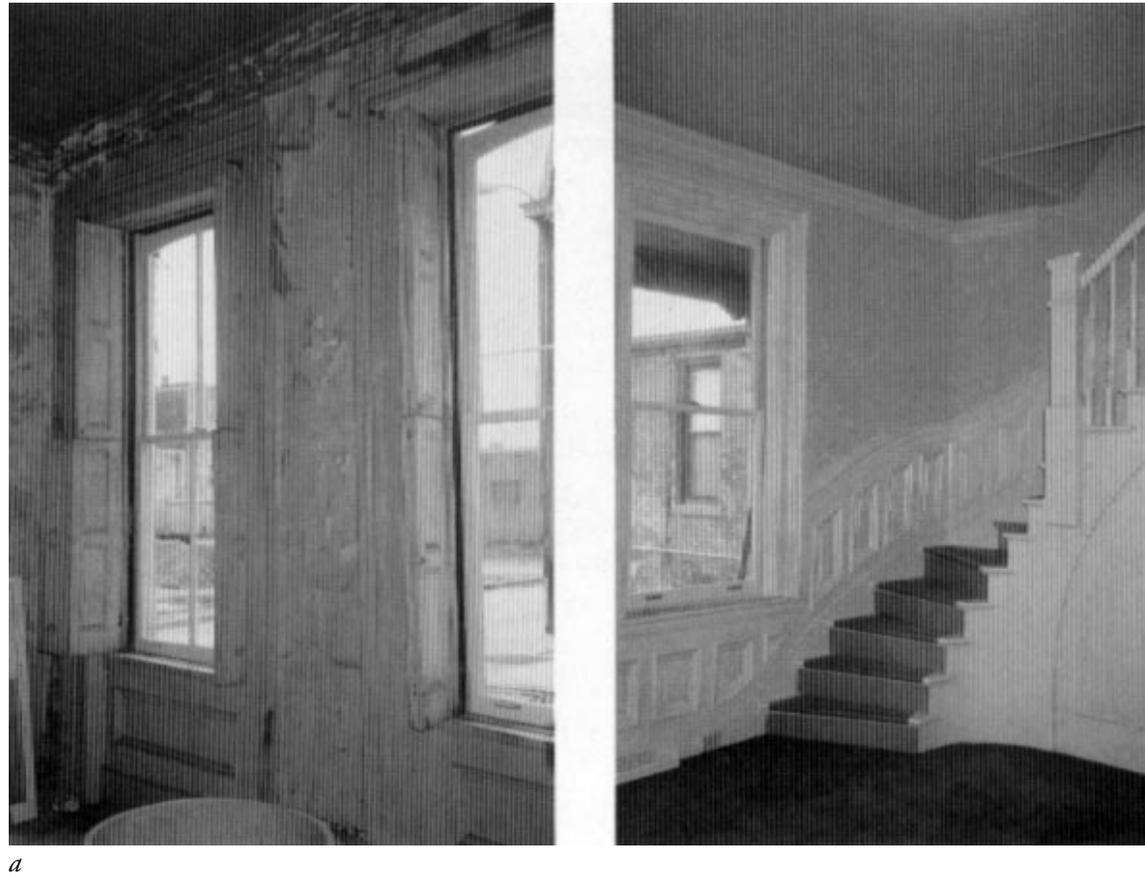
Rehabilitating historic dwelling units often includes some level of lead-paint hazard abatement. Whenever lead-base paint begins to peel, chip, craze, or otherwise comes loose (a), it should be removed in a manner that protects the worker as well as the immediate environment. In this example (b), the deteriorating lead-paint was removed throughout the apartment building and a compatible primer and finish paint applied.
Photos: Sharon C. Park, AIA.

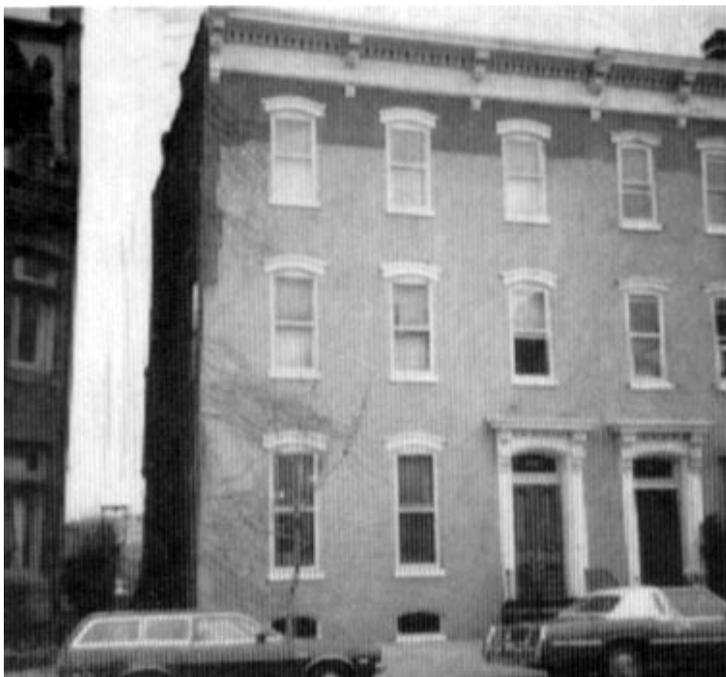
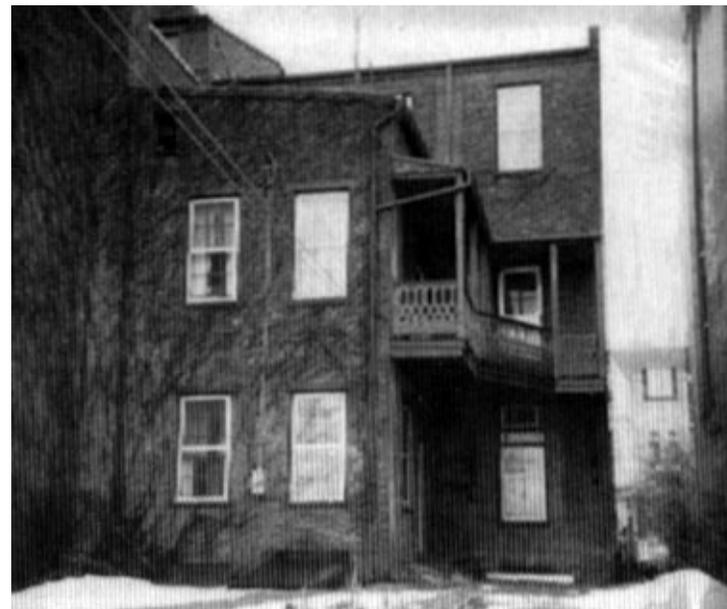
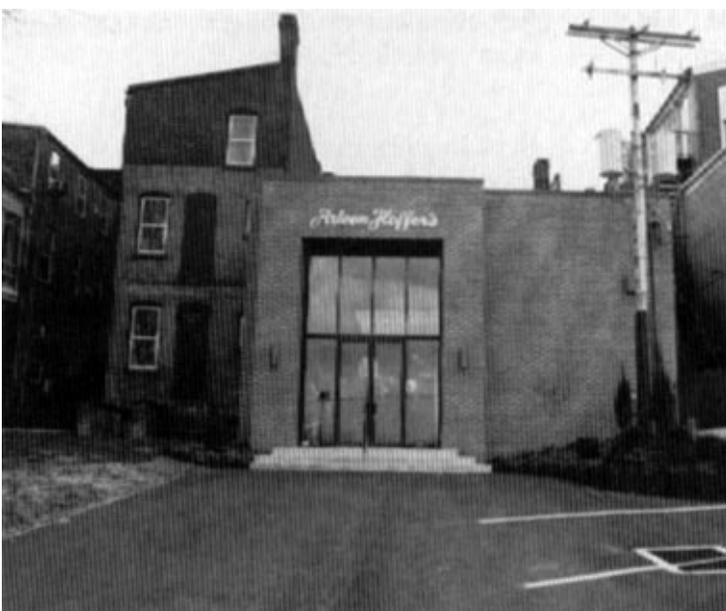
If a rear elevation of a historic building is distinctive and highly visible in the neighborhood, altering it may not meet the Standards. (a and b) This 3-story brick rowhouse featured a second story gallery and brick kitchen wing characteristic of other residences in the district which backed onto a connecting roadway. (c) In the rehabilitation, the wing and gallery were demolished and a large addition constructed that severely impacted the building's historic form and character.

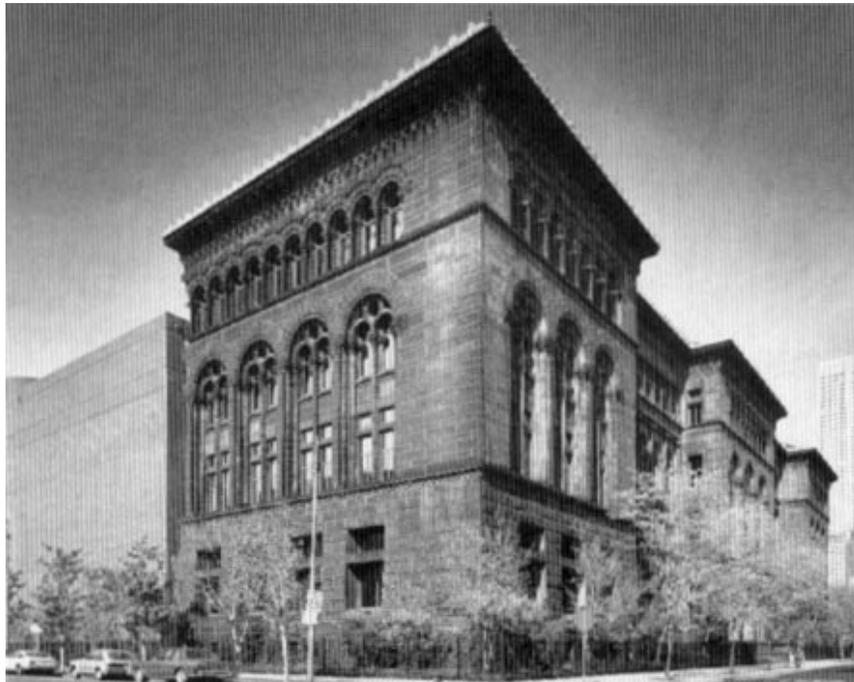
Rehabilitation, like Preservation, acknowledges a building's change over time; the retention and repair of existing historic materials and features is thus always recommended. However, unlike Preservation, the dual goal of Rehabilitation is to—respectfully—add to or alter a building in order to meet new use requirements. This downtown Chicago library was expanded in 1981 when additional space was required with light and humidity control for the rare book collection. The compatible 10-story wing was linked to the historic block on side and rear elevations. Its simple design is compatible with the historic form, features, and detailing; old and new are clearly differentiated. Photo: Dave Clifton.

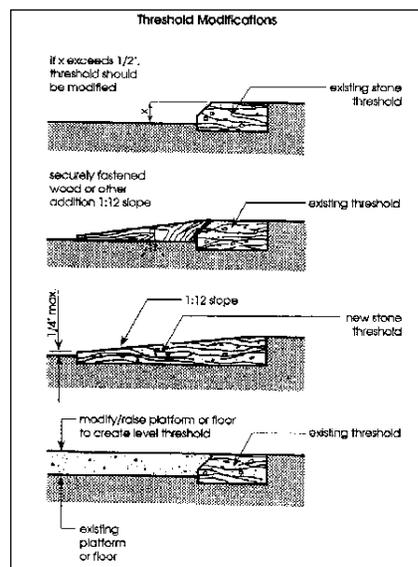
Making a building accessible to the public is a requirement under the Americans with Disabilities Act of 1990, whatever the treatment. Full, partial, or alternative approaches to accessibility depends upon the historical significance of a building and the ability to make changes. In these examples, thresholds that exceed allowable heights were modified several ways to increase accessibility, without jeopardizing the historic character. Drawing: Uniform Federal Accessibility Standard (UFAS) Retrofit Manual.
