PENNSYLVANIA HISTORIC RESOURCE SURVEY FORM-PHOTO/SITE PLAN SHEET

Survey Code/Tax Parcel/Other: Multiple Tax Parcels (A018)County: BucksMunicipality: Chalfont BoroughAddress: MultipleHistoric Name/Other Name: Derstine Residential Grouping

Site Plan/Photograph Location Map Derstine Residential Grouping - A018

S.R. 0202, Section 700
Montgomery and Bucks Counties, Pennsylvania

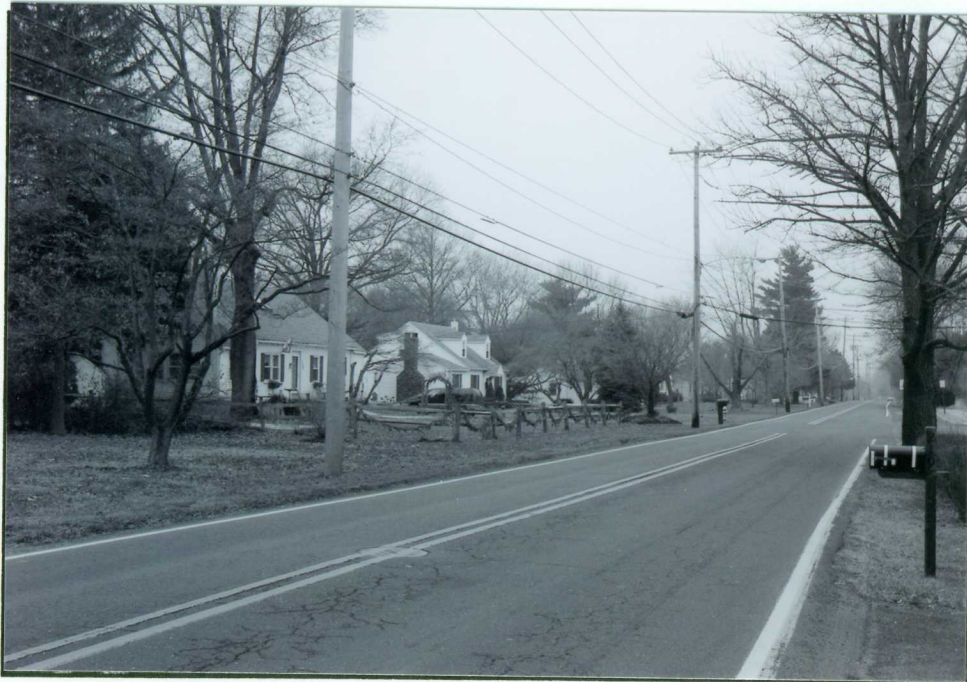
Photograph 2: Derstine Residential Grouping - This streetscape photograph is representative of the Derstine Residential Grouping. Note the lack of organized landscaping, sidewalks or other unifying features. View looking northwest along Bristol Road (January 2006).

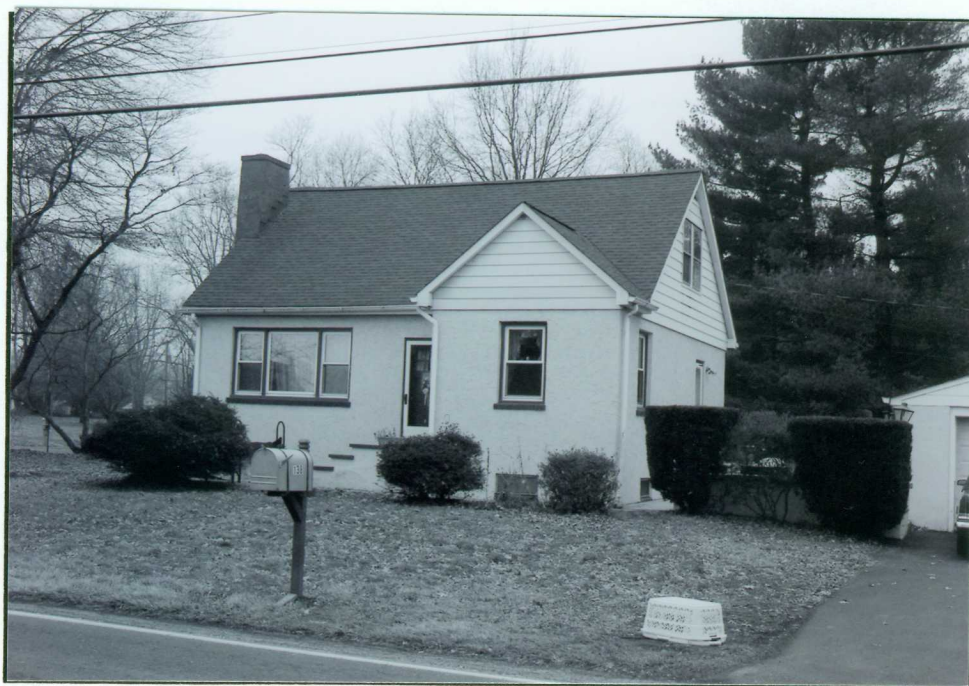
Photograph 3: Derstine Residential Grouping - This photograph is a representative example of a Minimal Traditional style dwelling. This dwelling is a common unadorned example of its architectural type. View looking south (January 2006).

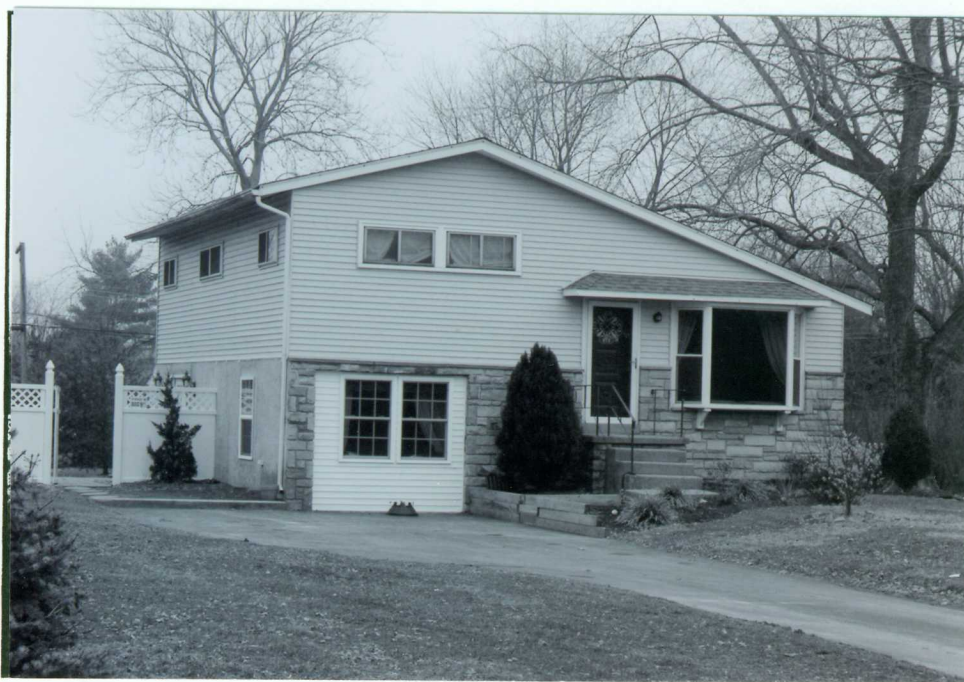
Photograph 4: Derstine Residential Grouping - This photograph is a representative example of a Split-level dwelling. This dwelling is a common example of its architectural type. Note the modern doors, windows, and cladding. View looking east (January 2006).

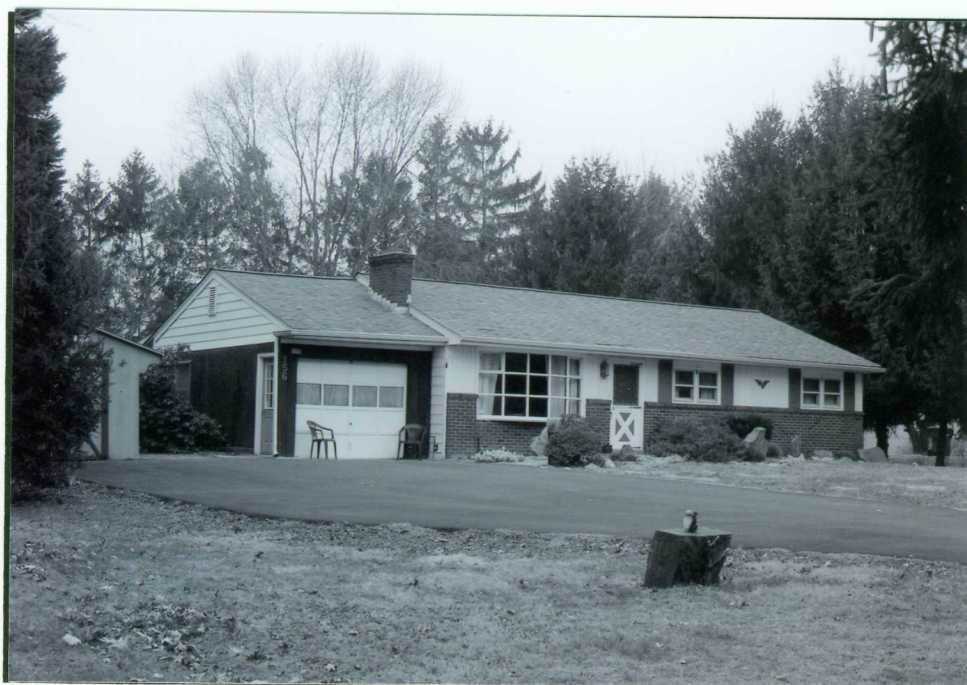
Photograph 5: Derstine Residential Grouping - This photograph is a representative example of a Ranch style dwelling. This dwelling is a common, unadorned example of its architectural type. View looking west (January 2006).

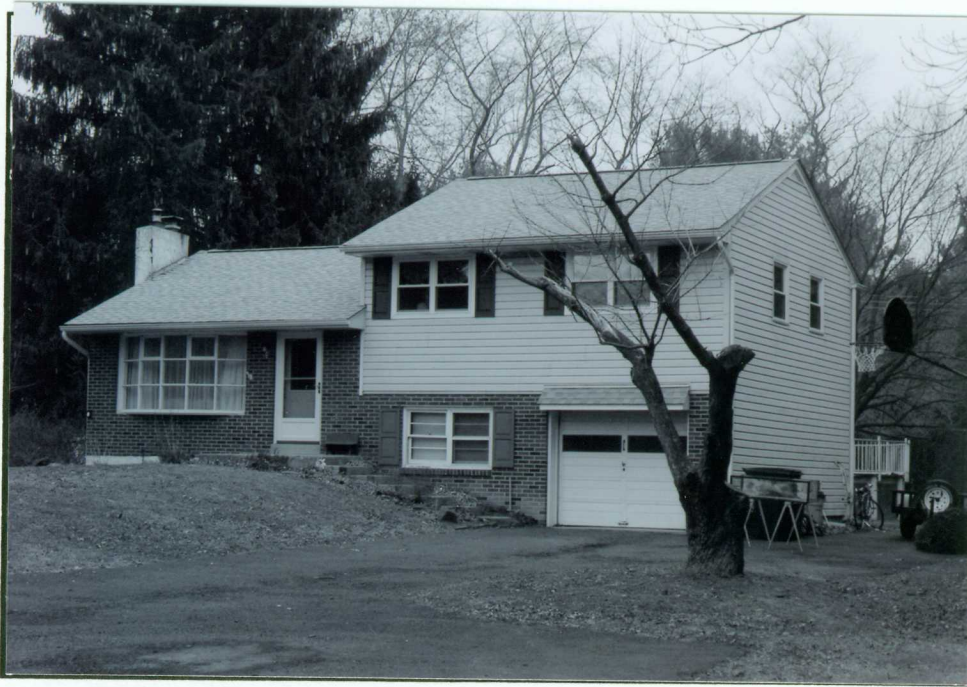
Photograph 6: Derstine Residential Grouping - This photograph is a representative example of a Split-level dwelling. This dwelling is a common, unadorned example of its architectural type. View looking northeast (January 2006).

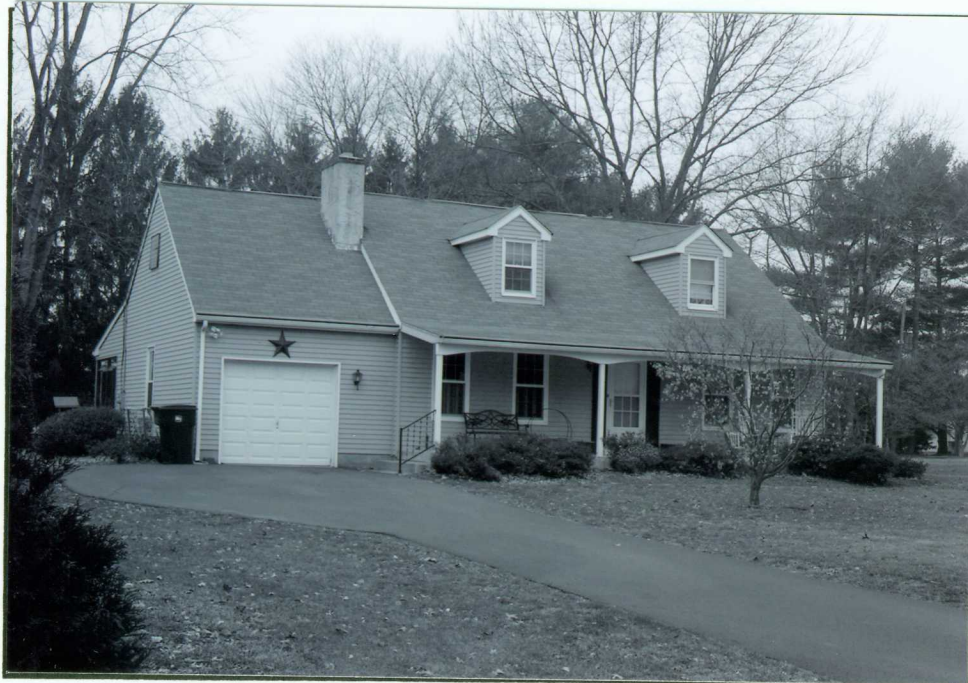
Photograph 7: Derstine Residential Grouping - This photograph is a representative example of a Colonial Revival dwelling. Note the modern doors, windows, and cladding. View looking west (January 2006).

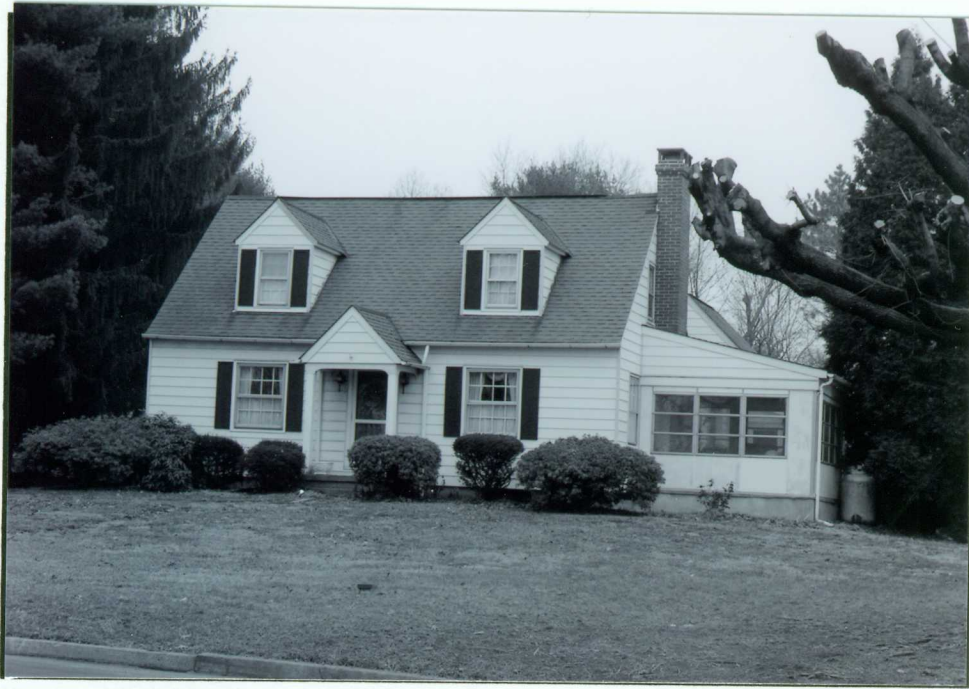
Photograph 8: Derstine Residential Grouping - This photograph is a representative example of a Colonial Revival dwelling. This dwelling is a common, unadorned example of its architectural type. Note the enclosed shed roof porch. View looking northeast (January 2006).

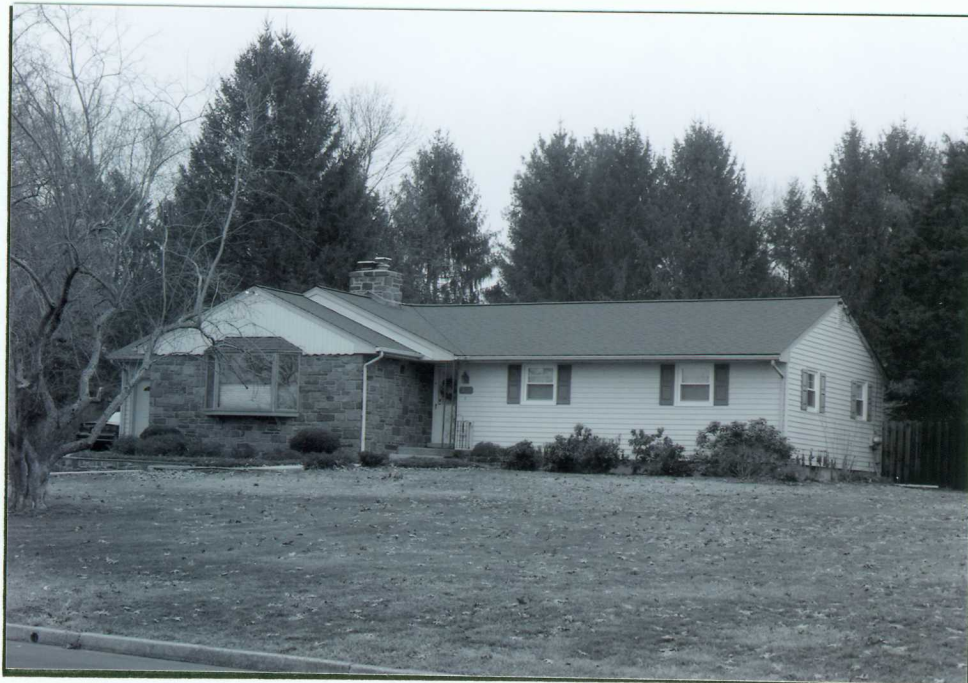
Photograph 9: Derstine Residential Grouping - This photograph is a representative example of a Ranch style dwelling. This dwelling is a common, unadorned example of its architectural type. The dwelling features modern cladding, doors, and windows. View looking north (January 2006).

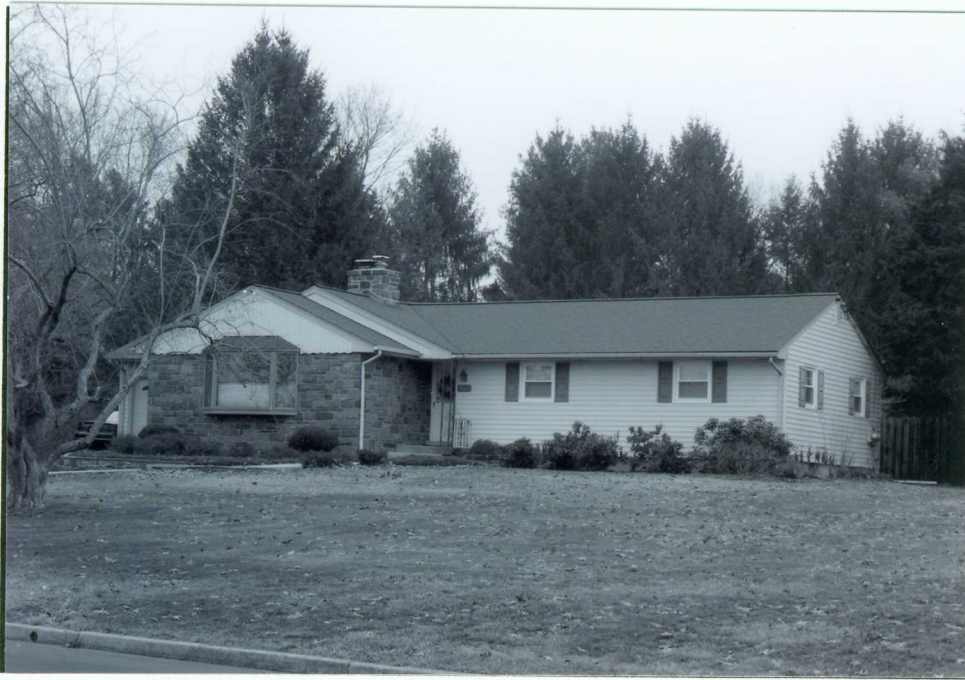
Photograph 10: Derstine Residential Grouping - This photograph is a representative example of a Ranch style dwelling. This dwelling features modern cladding, windows, and doors. View looking north-east (January 2006).

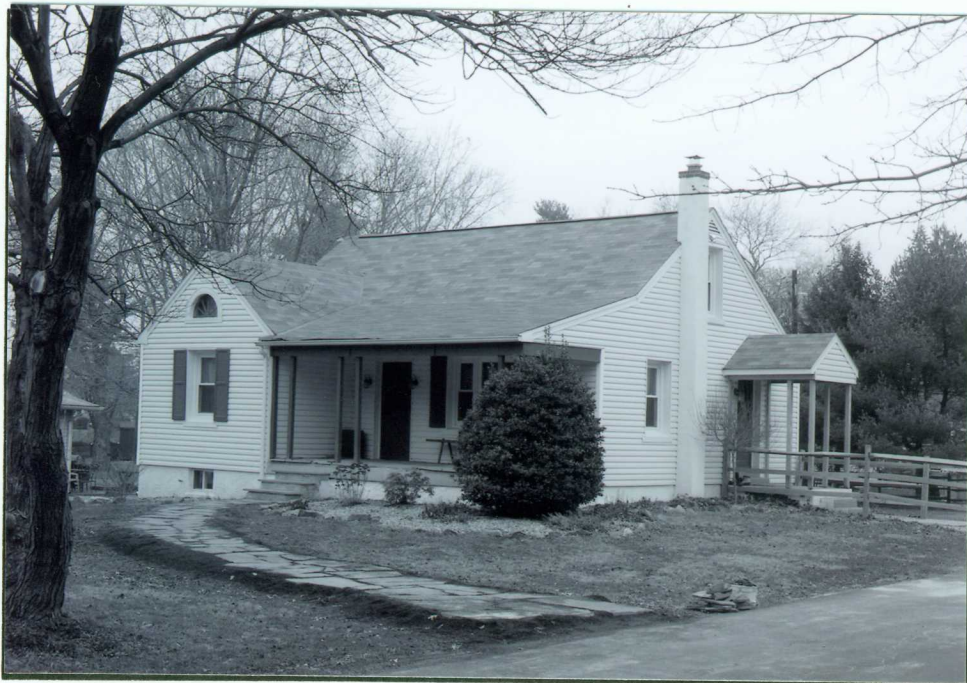
Photograph 11: Derstine Residential Grouping - This photograph is a representative example of a Minimal Traditional dwelling. Note the modern cladding, windows, doors, and additions. View looking north (January 2006).
