PENNSYLVANIA HISTORIC RESOURCE SURVEY FORM-PHOTO/SITE PLAN SHEET

Survey Code/Tax Parcel/Other: Multiple Tax Parcels (A025)County: BucksMunicipality: Warrington TownshipAddress: MultipleHistoric Name/Other Name: Moore Farm Residential Grouping

S.R. 0202, Section 700
Montgomery and Bucks Counties, Pennsylvania

RESOURCE NAME: Moore Farm Residential Grouping

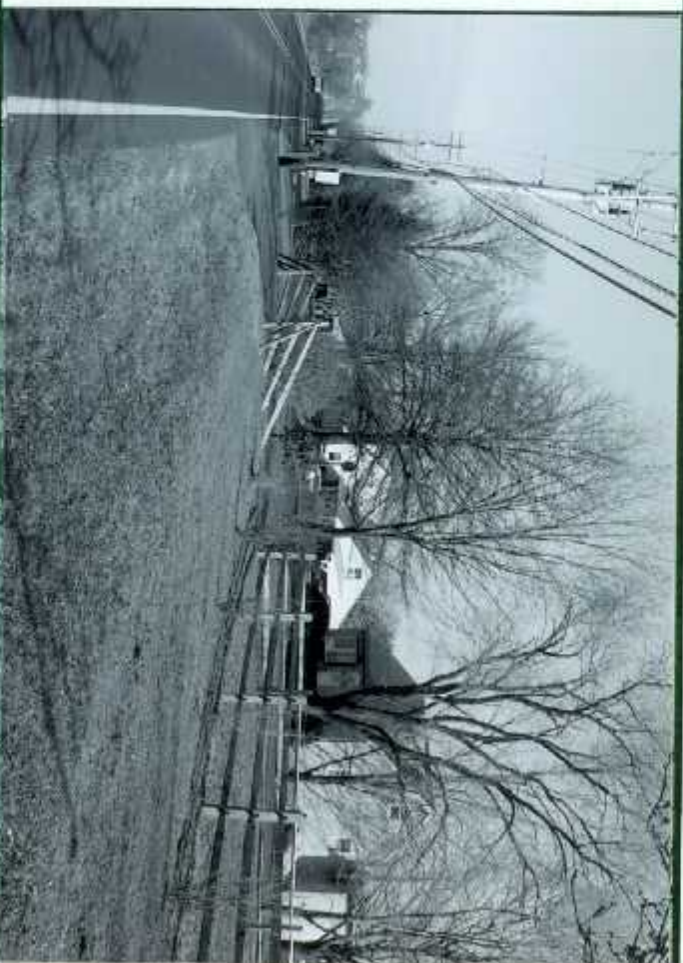
1

Streetscape along Stump Road

NE

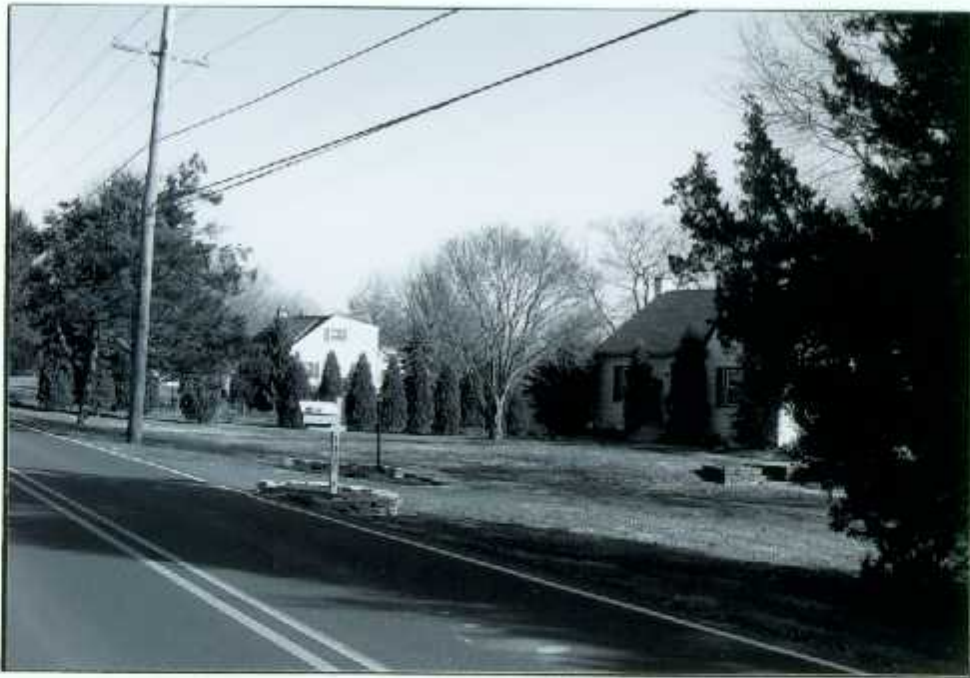
Photograph 2: Moore Farm Residential Grouping - Streetscape photograph of the Residential Grouping. Note the unplanned landscaping, lack of sidewalks, and other unifying features lacking from this grouping. View facing east (January 2006).

Additional buildings, structures, and elements within the grouping include sheds, garages, and retaining walls. Many of the sheds and garages have undergone alterations similar to the dwellings. The retaining walls are constructed of either concrete or stone. The grouping has no unifying features such as sidewalks, curbing, or street lights. Similarly, plantings are sporadic throughout the grouping, and there are no uniform landscaping features.

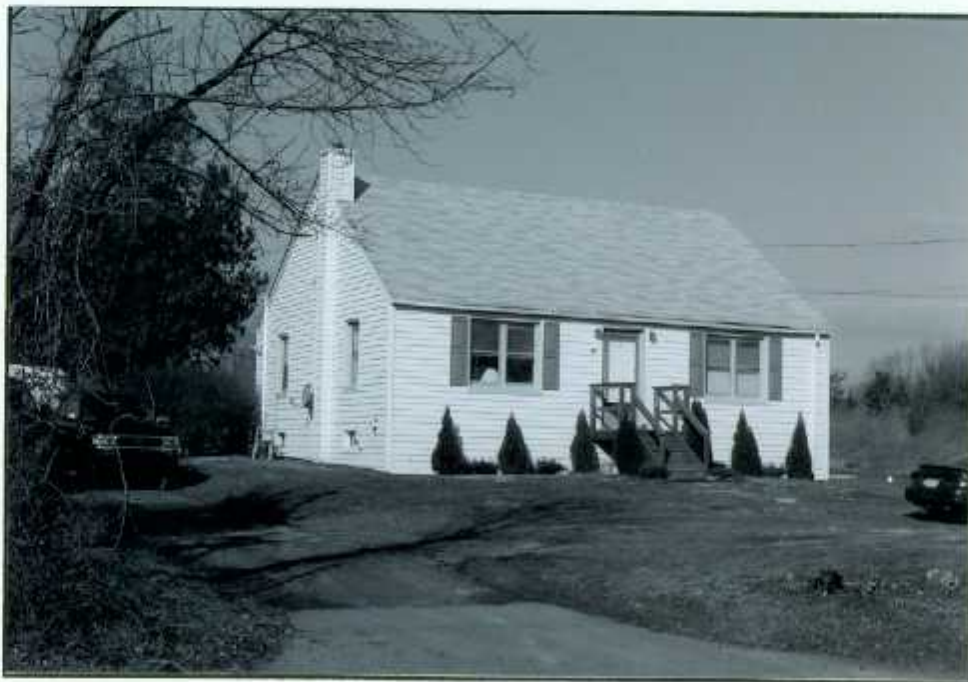
Photograph 3: Moore Farm Residential Grouping - Photograph of a representative example of a Minimal Traditional style dwelling. This style of dwelling is common throughout the project area and is an unadorned example of this architectural style. View facing north (January 2006).

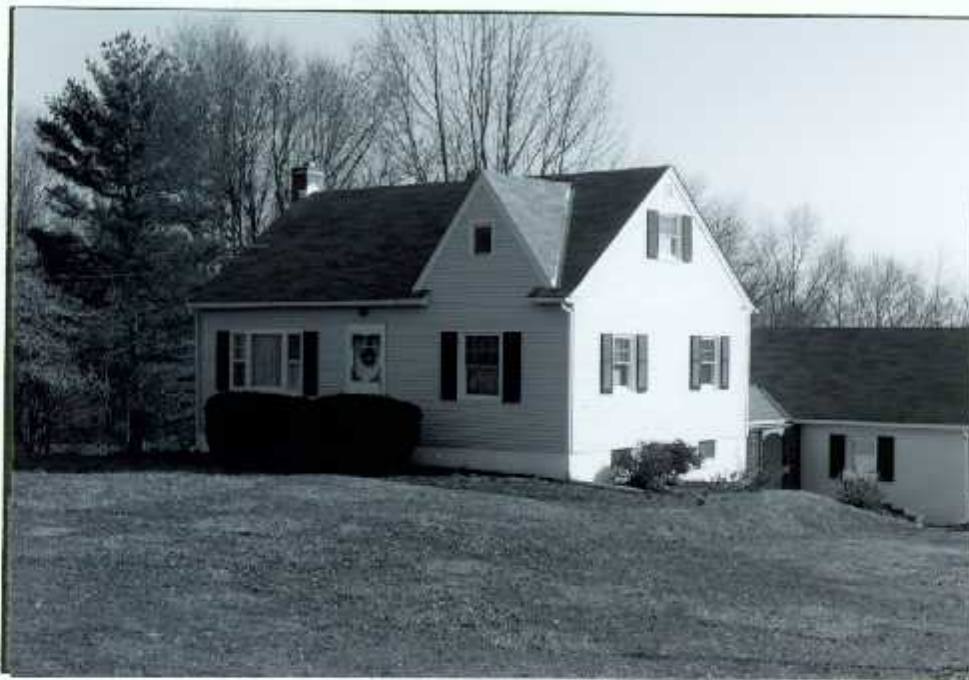
Photograph 4: Moore Farm Residential Grouping - Photograph of a representative example of a Minimal Traditional style dwelling. Note the multiple rear additions, vinyl cladding, and modern windows. View facing east (January 2006).

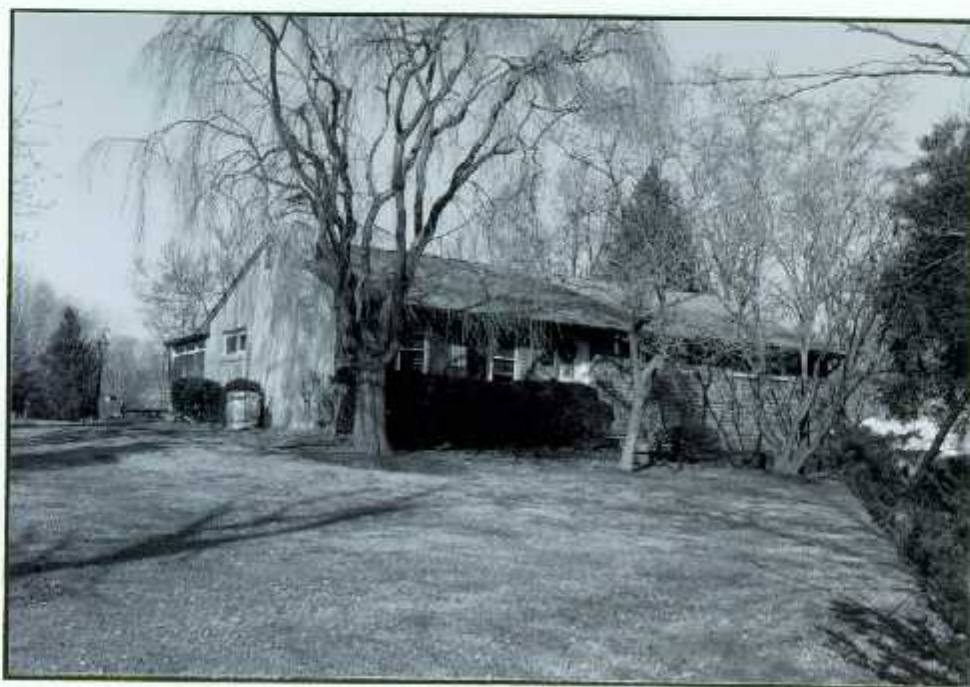
Photograph 5: Moore Farm Residential Grouping - Photograph of a representative example of a Ranch style dwelling. Note the rear enclosed porch and modern entrance. View facing north (January 2006).

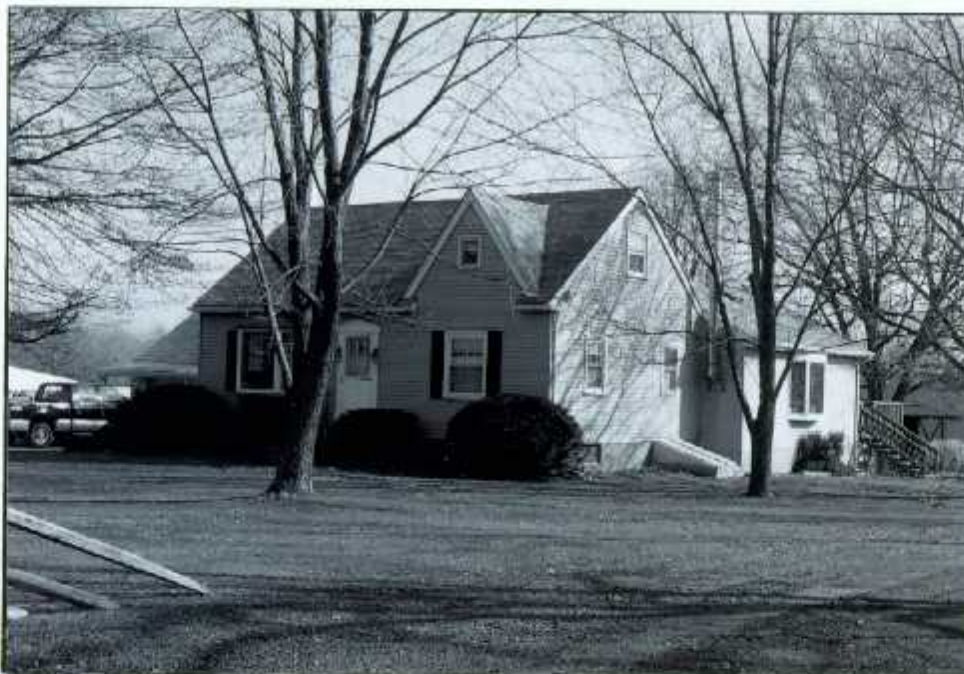
Photograph 6: Moore Farm Residential Grouping - Photograph of a representative example of a Minimal Traditional style dwelling. Note the rear addition, modern cladding, and modern windows. View facing east (January 2006).

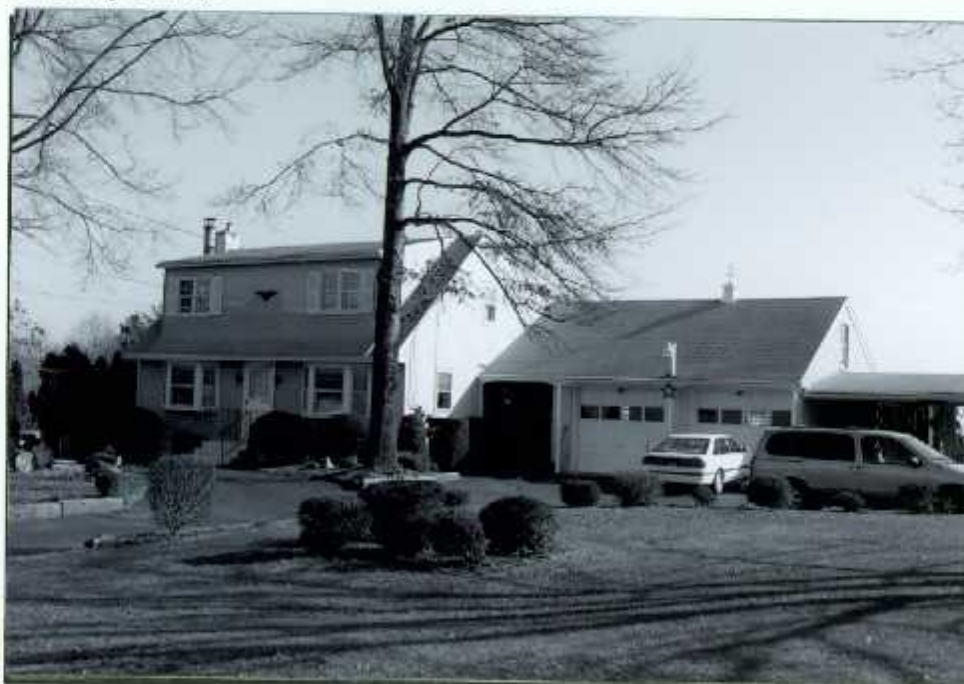
Photograph 7: Moore Farm Residential Grouping - Photograph of a representative example of a Minimal Traditional style dwelling. Note the second-story shed-roof dormer as well as the attached two-car garage. View facing east (January 2006).

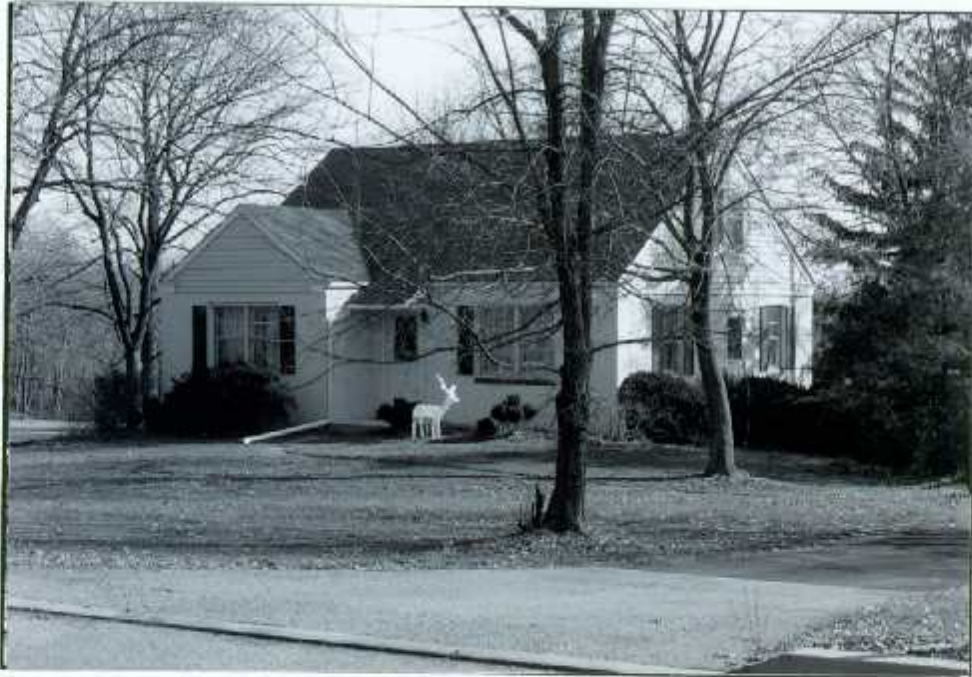
Photograph 8: Moore Farm Residential Grouping - Photograph of a representative example of a Minimal Traditional style dwelling. Note the gable front addition, vinyl cladding, and modern windows. View facing southeast (January 2006).

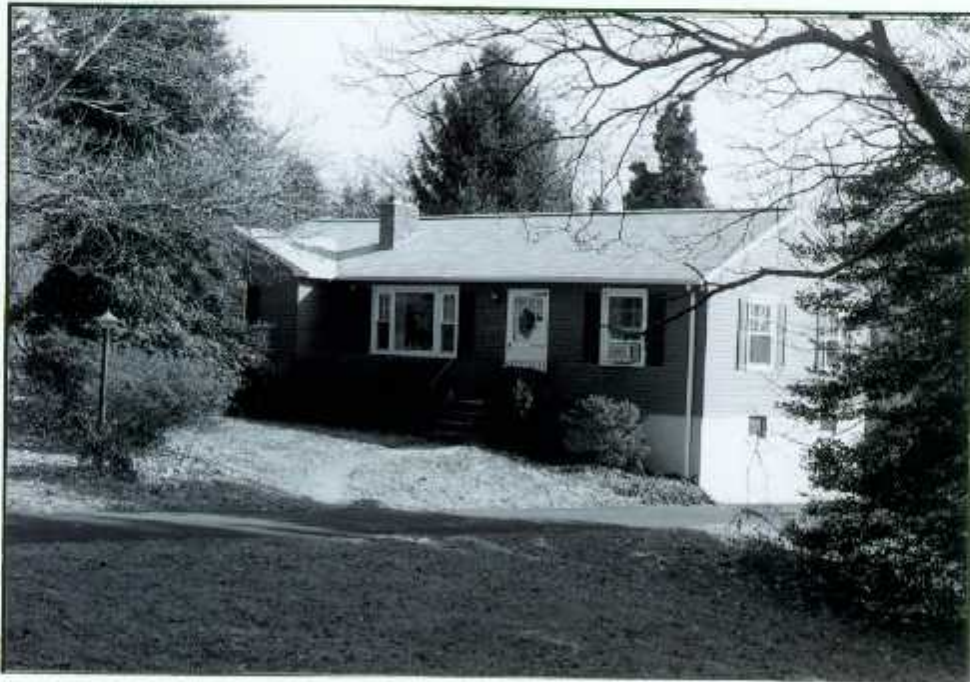
Photograph 9: Moore Farm Residential Grouping - Photograph of a representative example of a Ranch style dwelling. This style of dwelling is common throughout the project area and is an unadorned example of this architectural style. View facing southeast (January 2006).
