PENNSYLVANIA HISTORIC RESOURCE SURVEY FORM-PHOTO/SITE PLAN SHEET

Historic Name/Other Name: Stoller Heights Residential Grouping

Site Plan/Photograph Location Map Stoler Heights Residential Grouping - A022

S.R. 0202, Section 700
Montgomery and Bucks Counties, Pennsylvania

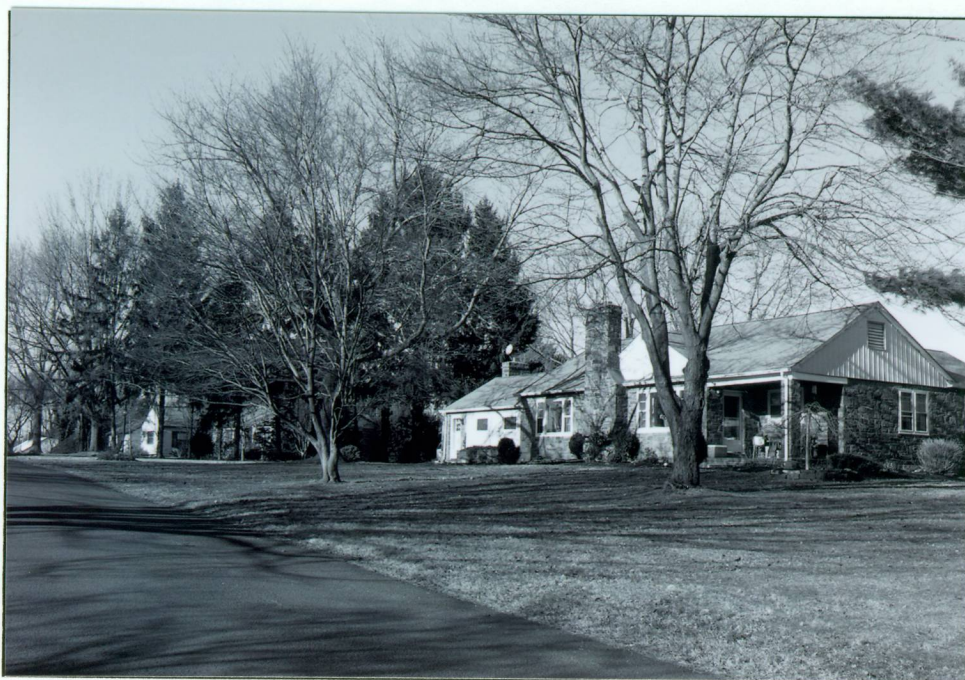
Photograph 2: Stoler Heights Residential Grouping - Streetscape photograph of the Residential Grouping. Note the lack of organized landscaping, sidewalks, curbing, or other unifying features. View facing north (January 2006).

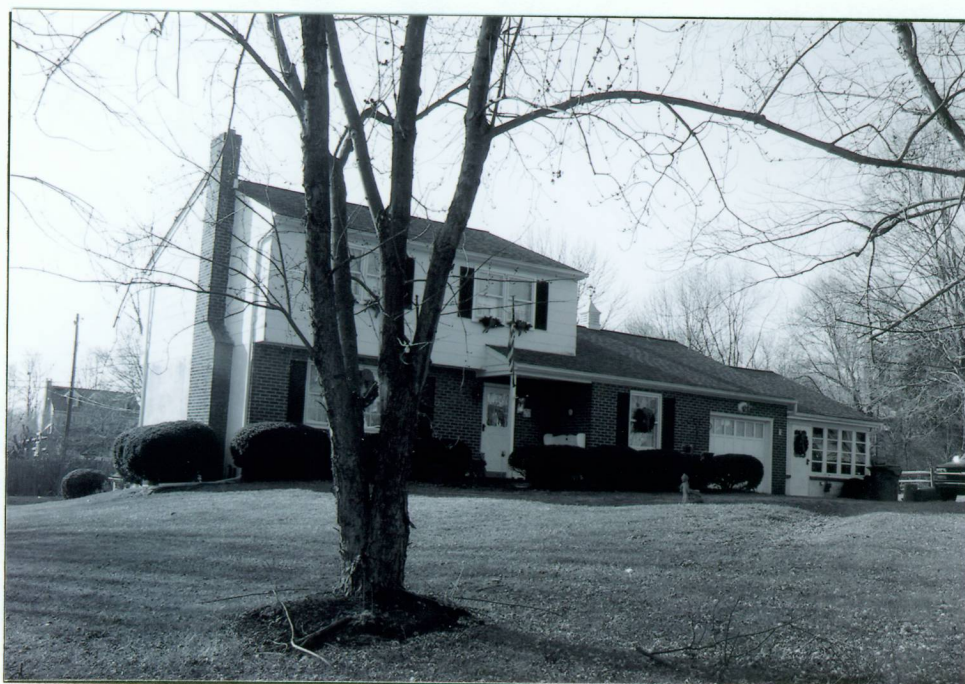
Photograph 3: Stoler Heights Residential Grouping - Photograph of a representative example of a Colonial Revival style dwelling. Note the vinyl cladding, modern windows and doors, as well as a small side gable addition. View facing west (January 2006).

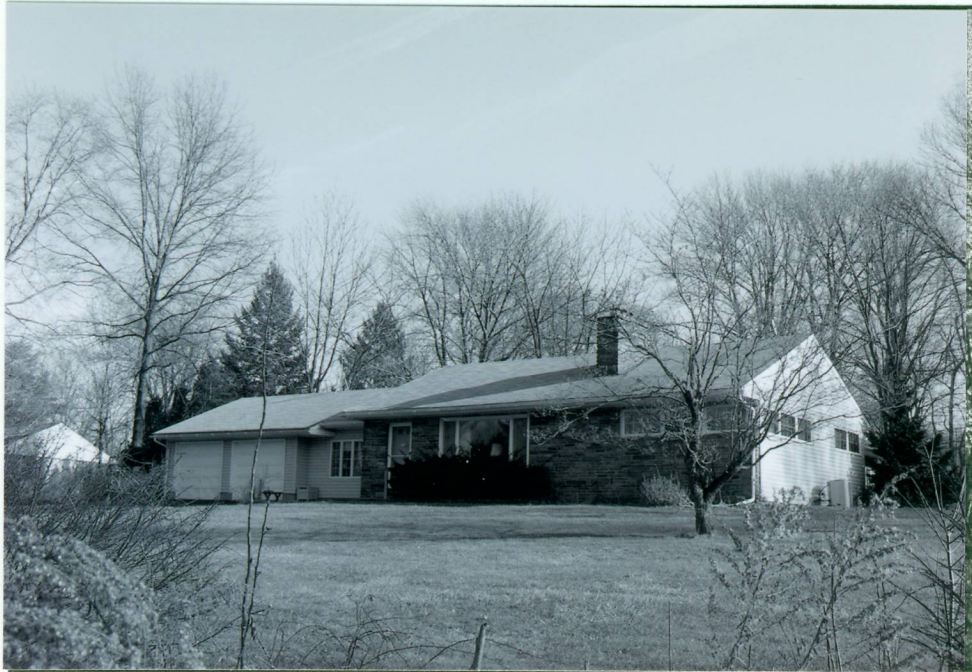
Photograph 4: Stoler Heights Residential Grouping - Photograph of a representative example of a Ranch style dwelling. This dwelling is an unadorned example of its architectural style and features a number of modern intrusions. View facing east (January 2006).

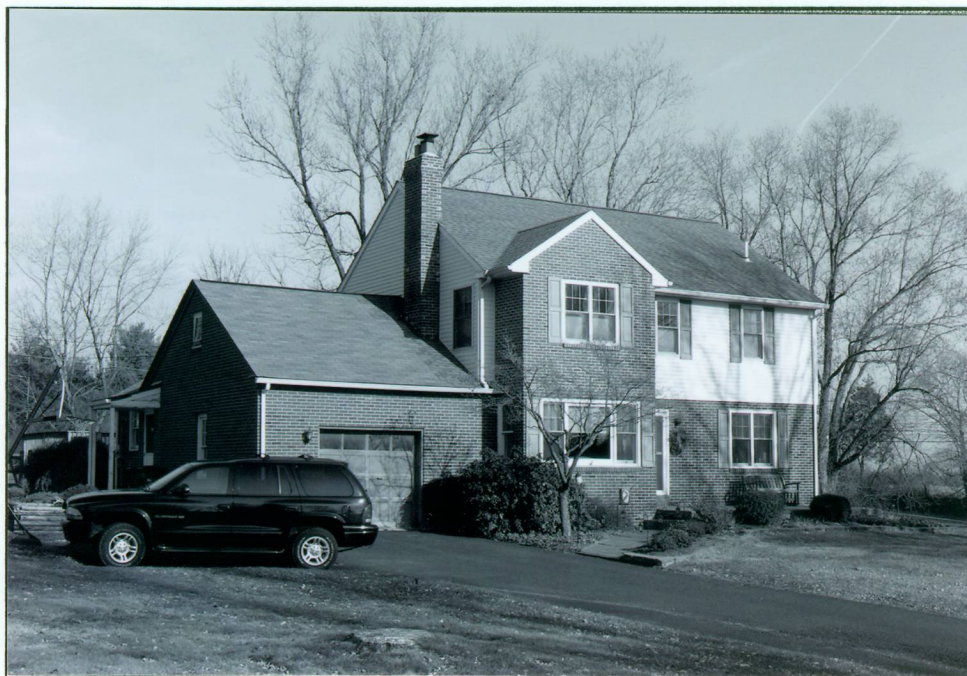
Photograph 5: Stoler Heights Residential Grouping - Photograph of a representative example of a Minimal Traditional style dwelling. Note the modern cladding, windows, and doors. View facing northeast (January 2006).

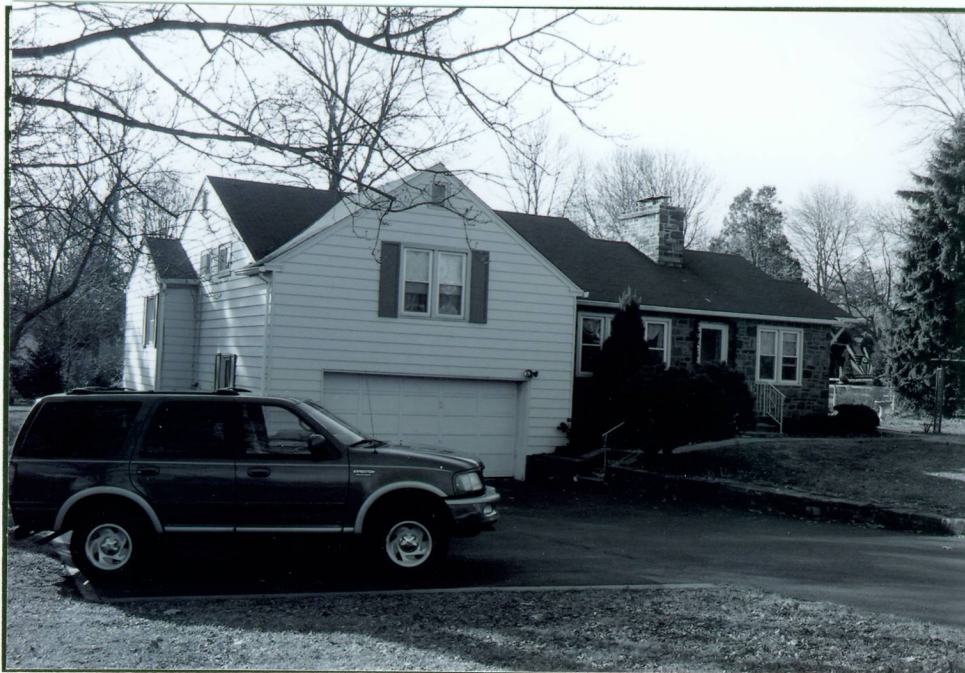
Photograph 6: Stoler Heights Residential Grouping - Photograph of a representative example of a Minimal Traditional style dwelling. This dwelling is an unadorned example of its architectural style and features a number of modern intrusions. View facing west (January 2006).

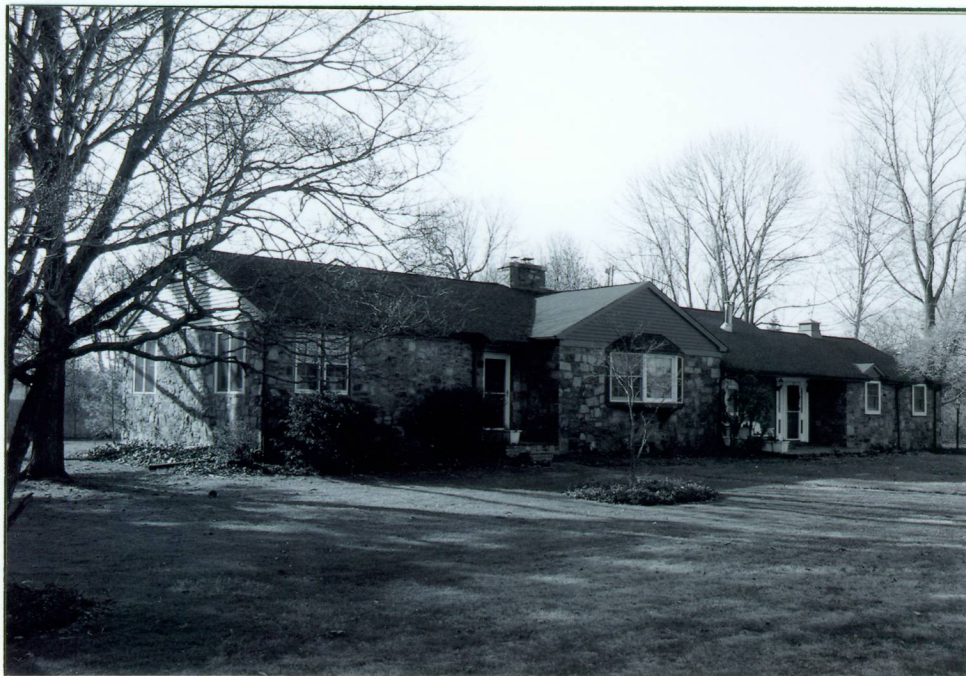
Photograph 7: Stoler Heights Residential Grouping - Photograph of a representative example of a Ranch style dwelling. Note the modern doors, windows, and side gable additions. View facing west (January 2006).

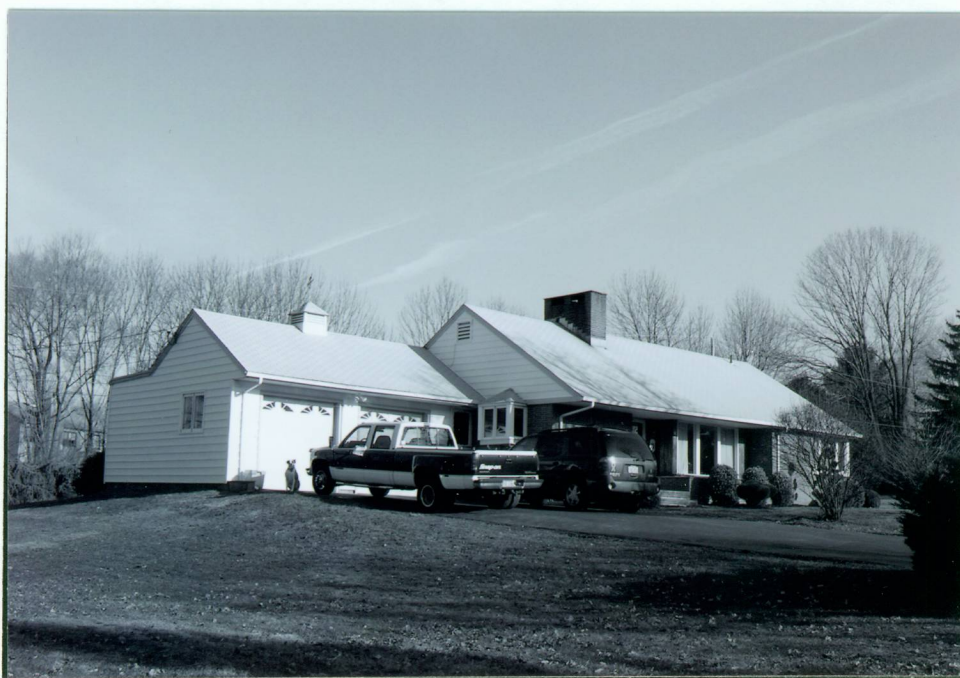
Photograph 8: Stoler Heights Residential Grouping - Photograph of a representative example of a Ranch style dwelling. Note the modern additions, windows, and doors. View facing east (January 2006).

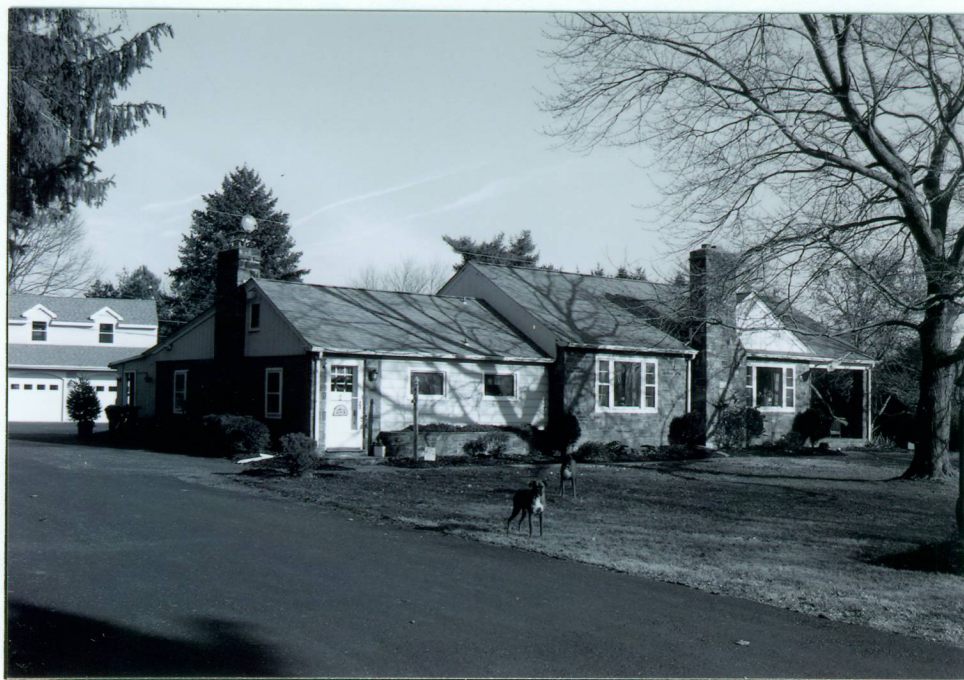
Photograph 9: Stoler Heights Residential Grouping - Photograph of a representative example of a Minimal Traditional style dwelling. Note the multiple additions, modern detached garage, and side gable porch. View facing east (January 2006).
