INTERLOCKING TOWERS ON AMTRAK'S RIGHT-OF-WAY IN PENNSYLVANIA

**A Historic Architectural and Industrial Examination
And Determination of Eligibility for Listing into the
National Register of Historic Places
of 19 Extant Towers along the former Pennsylvania Railroad
between Morrisville and Marcus Hook (the Northeast Corridor)
and
between Philadelphia and Harrisburg (the Keystone Corridor)**

JOHN BOWIE ASSOCIATES, Historical Architects

October 11, 2011

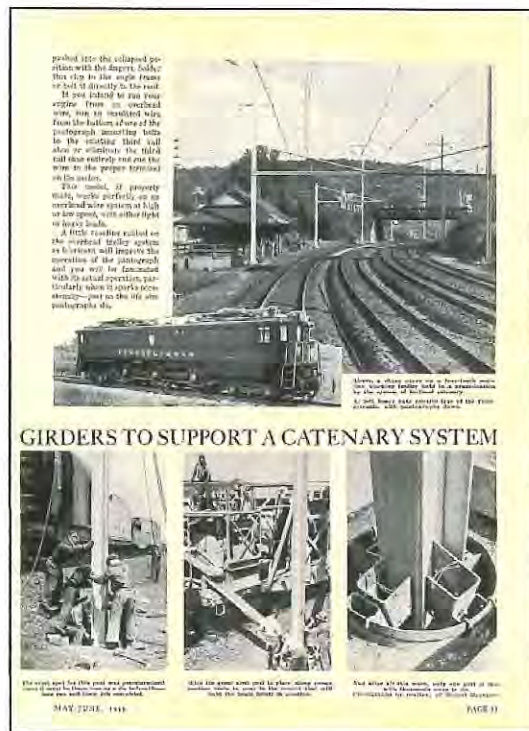
Fig. 1: copy of article from *Model Builder* magazine, page 15, dated May/June 1938 describing how the model railroader can realistically build model catenary wire systems. However, note that the photographs in the article show the construction of the PRR catenary lines in front of Gap Station (in Lancaster County, PA). The photos were most likely taken just before publication of the magazine. (Article found by Steven C. Smith from www.trainlife.com)

Immediately thereafter, the PRR decided to electrify all of its remaining trackage between Philadelphia and Harrisburg, including the remainder of the main line, the Trenton Cut-Off, the Philadelphia & Downingtown Low Grade and the Atglen & Susquehanna Low Grade.¹¹ Electrification began on these lines in January 1937, utilizing steel H-poles spaced between 250 and 300 feet apart – less costly and easier to install than the tubular steel poles used on the earlier lines. On January 15, 1938, the first passenger train was operated between Philadelphia and Harrisburg (pulled by the newly-delivered GG-1 Number 4859); freight service was initiated three months later (see Fig. 1).¹²

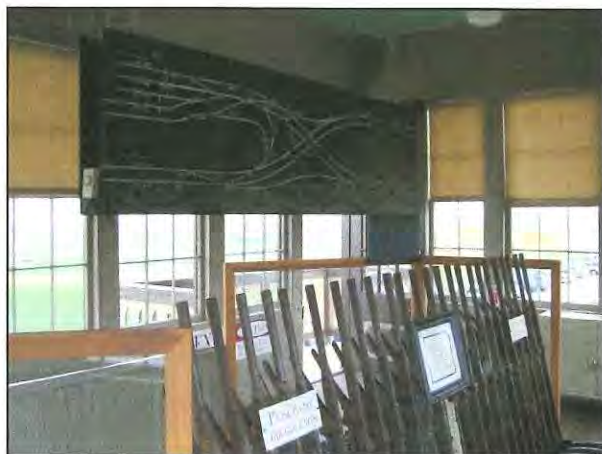
Fig. 2 (above, left): general view of the interior of J Tower at the Strasburg Railroad in Lancaster County, PA. This tower was relocated from its original location in LeMoyne, PA by the Lancaster Chapter of the National Railway Historical Society (NRHS) in 1983. The view features the Armstrong switch levers as well as the reconstructed model board (above). (Photo by Tony White, Western Connecticut Chapter, NRHS.)

the switch or signal it controlled,¹⁹ and turned 90-degrees again (either horizontally for a track switch or vertically for a semaphore signal) to attach to the device. The rods were typically ganged together and generally were supported on rollers set just above the grade. It took a strong-armed operator to be able to successfully move the switch lever – hence the term “Armstrong,” which became an industry moniker (see Figs. 2, 3 and 4).

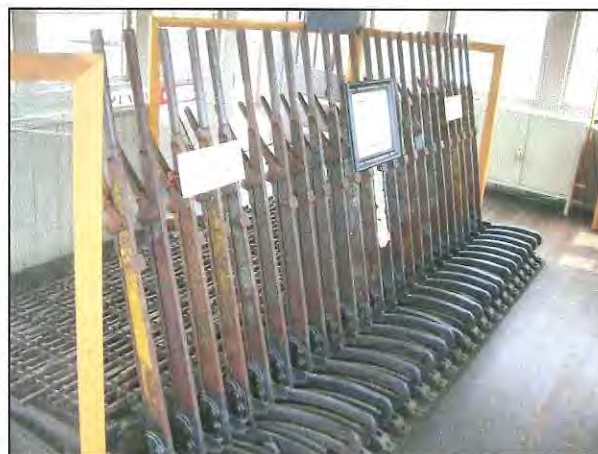
Fig. 3 (above, right): detail view of the Armstrong switch levers at J Tower in Strasburg, PA; note also the metal locking bed placed on the floor directly behind the switch levers. (Photo by Tony White, Western Connecticut Chapter, NRHS)

The roofs of first-period towers were typically hipped in shape, and generally contained a center cupola. On some towers, the cupola was elaborately-sized, with its own hipped roof. However, the roofs were generally clad with slate shingles or else standing seam metal (to prevent flying cinders from catching the building on fire) (see Figs. 7 and 8 – also, refer back to Fig. 3).

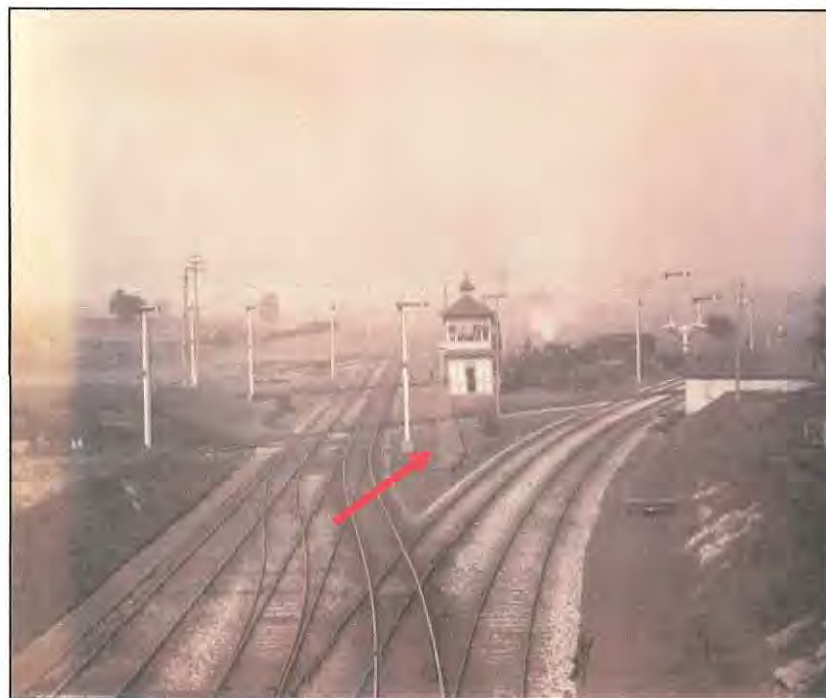
Fig. 4 (above): copy of image of Dillerville Junction Tower, taken in the 1890s (exact date unknown) by William H. Rau, and published in *Traveling the Pennsylvania Railroad: the Photographs of William H. Rau*, edited by John C. Van Horne with Eileen E. Drelick, (University of Pennsylvania Press, copyright 2002), page 105. This extraordinary image (which looks west – the main line to Harrisburg curves off to the right and the branch line to Columbia goes straight) shows not only the tower (long ago removed) but also the above-grade switch and semaphore signal piping (red arrow).

Evidently, the Landisville Block Station was the second tower on this location. In 1863, a combination tower/passenger station was constructed at this site; it was a two-story building remarkably similar in appearance to Dillerville Junction (just three miles to the east – see Fig. 4 of this report) and Gap (just 15 miles to the east – see Fig. 7 of this report), as well as other towers on the Keystone Line (see Fig. 39).³⁵

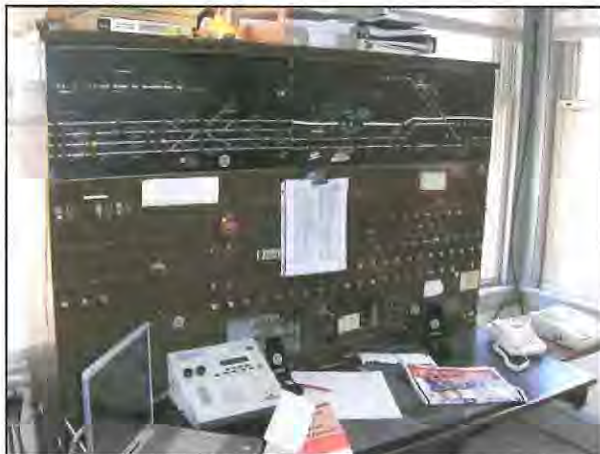
Fig. 6: detail of CTC switch machine at Overbrook Tower; the model board and another electro-pneumatic switch machine are located behind the photographer (Photo by John R. Bowie, A.I.A.)

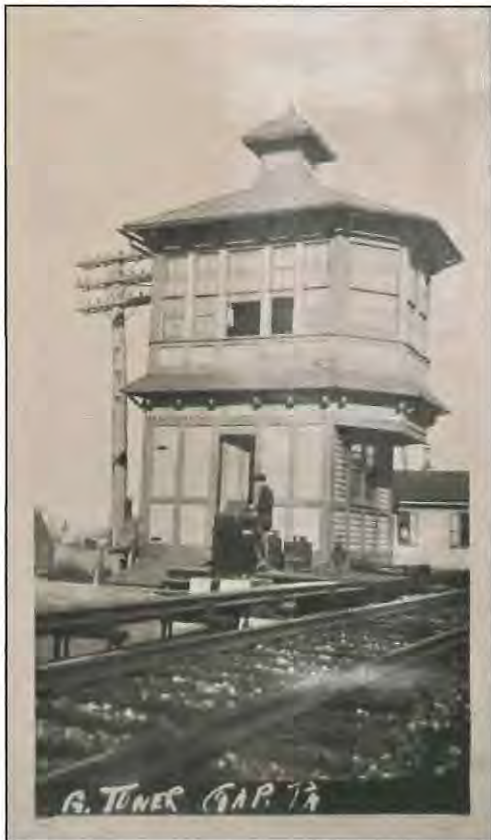
Fig. 7 (left): trackside (south) and west elevations of G Tower (in Gap, Lancaster County, PA), constructed in 1884 and photo taken as part of the Interstate Commerce Commission Valuation Survey of 1918 (National Archives Records Admin. Center, College Park, MD) – note also switch rods in foreground just beyond the tracks

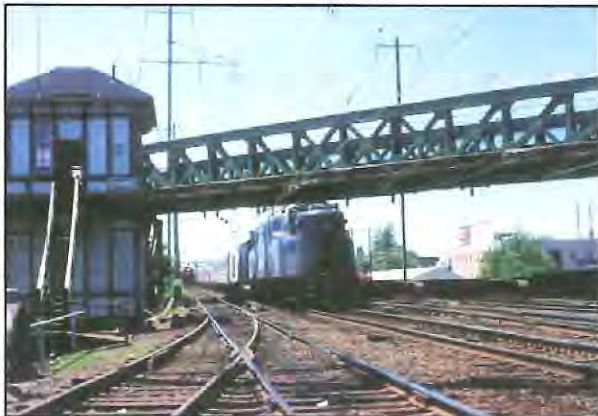
Fig. 9: 1973 photograph of the east elevation of Shore Tower (while still in operation) – note the cupola has been removed. Photo from www.thebluecomet.com a website of old PRR railroad images.

Originally, the PRR had first-period towers along its entire main line throughout Pennsylvania. However, as upgrades and realignments were made over the years, most were demolished and replaced with larger masonry buildings (although several survive intact in the Middle Division between Harrisburg and Hollidaysburg on the present-day Norfolk Southern RR freight line – not part of this study). The only surviving first-period tower within Amtrak's Northeast Corridor or Keystone Corridor is Shore Tower in Philadelphia (dating to 1896) (see Figs. 9 and 10).

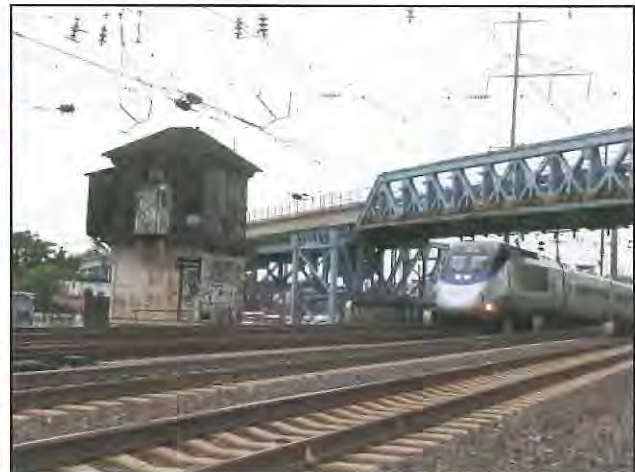
Fig. 10: north (trackside) and east elevations of Shore Tower in 2009; the bridge above the Amtrak train carries the SEPTA Market-Frankford elevated line; Kensington Avenue is beneath the Market-Frankford and passes beneath the PRR tracks (*photo by John R. Bowie, A.I.A.*)

Interestingly, Shore originally contained Armstrong switch machinery when it was constructed; however, it was later modified to contain an updated US&S Model 14 electro-pneumatic switch machine, and an addition was added onto the second floor in c.1930 to house the electric catenary power control board (see left side of Fig. 10).

Shore Tower – overall condition: fair

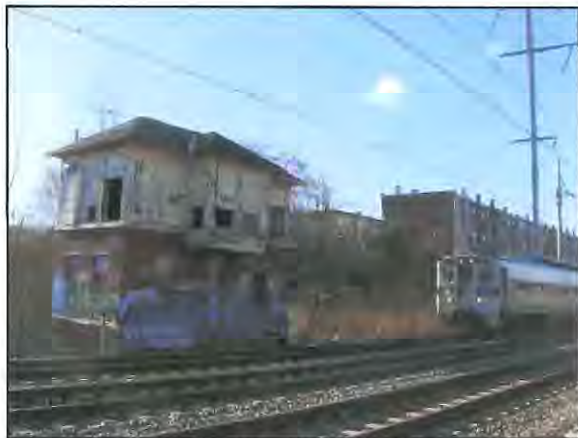
Fig. 12: west (trackside) and north elevations of Brill Tower in 2008 (*photo by John R. Bowie, A.I.A.*)

During the early years of this second period, the PRR was still constructing its towers with individual designs – they were not yet standardized in appearance. For example, Brill Tower, in Philadelphia was constructed in 1905 on a brick foundation with a wood frame second floor which contained a projecting trackside bay window; the building was rectangular in plan and had a hipped roof. However, Baldwin Tower (located seven miles away in Eddystone, Delaware County) was constructed at roughly the same time (c.1905), but it was square in plan, set on a stuccoed, terra-cotta foundation with a fenestrated wood-frame second floor (with no bay) and deeply-projecting Arts-&-Crafts style hipped roof. Further down the main line, just north of the Delaware line, Hook Tower (also c.1905) was a single-story brick building divided into two rooms, and containing a wood frame second floor for the switch machine (see Figs. 12-14).²²

²² Interestingly, Brill and Baldwin Towers were both constructed with Armstrong lever electro-mechanical switch machines, which continued to be used until the towers were decommissioned. Brill's machine was disassembled and moved in its entirety to the relocated and restored former Lemo (Lemoyne) Tower – renamed J Tower, at the Strasburg Railroad, in Lancaster County. Hook Tower contained a US&S Model 13 electro-pneumatic switch machine. It is also interesting to note the inconsistencies in the framing systems of these towers. The roof framing for each tower was composed of wood rafters and wood sheathing beneath fire-proof shingles, such as slate or tile – although at present, each is covered with asphalt-composition shingles. However, the floor framing and decking at Hook and Baldwin was concrete covering steel beams; at Brill, it was wood flooring on top of wood joists. Another inconsistency in the designs of these towers was the second floor stairways – Brill and Baldwin both contained internal stairways, and Hook had an outdoor second floor stair.

Brill Tower – overall condition: poor

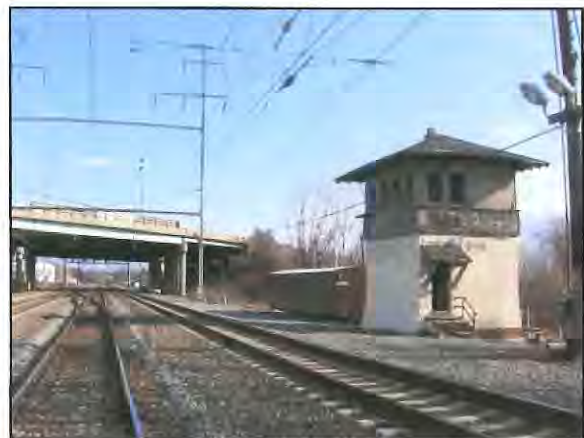
Fig. 13: west (trackside) and south elevations of Baldwin Tower in 2008 (*photo by J.R. Bowie, A.I.A.*)

Baldwin Tower – overall condition: poor

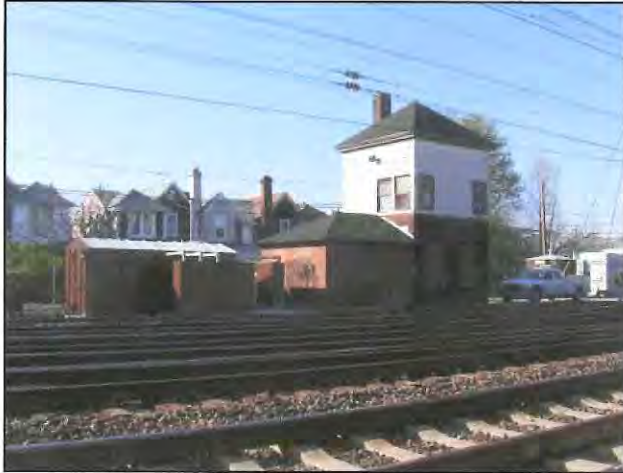
Fig. 14: west (trackside) and north elevations of Hook Tower in 2008 (photo by John R. Bowie, A.I.A.)

Hook Tower – overall condition: fair

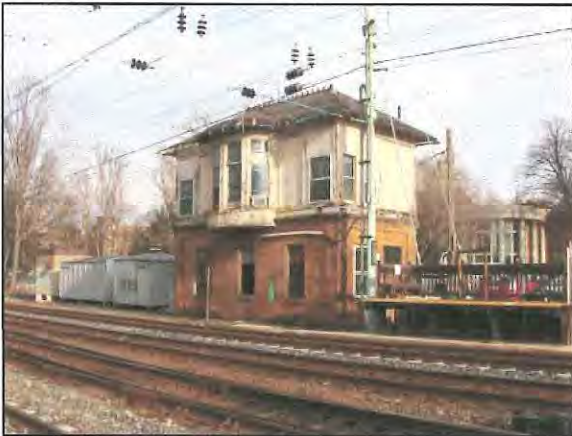
Fig. 15 (above, left): south (trackside) and east elevations of Bryn Mawr Tower in 2008 (photo by John R. Bowie, A.I.A.)

At roughly the same time, the PRR constructed two remarkably similar towers – Bryn Mawr and Paoli, in 1896 on the Keystone Line. Bryn Mawr controlled a full four-track crossover,²³ and Paoli also controlled a full four-track crossover as well as the entrance to Paoli Yard, a large passenger and freight facility. Both towers contained US&S Model 14 electro-pneumatic switch machines and both towers were two stories in height with stone foundations, brick,

load-bearing, first floor exterior walls (and containing decorative, recessed panels in the elevations between windows) and wood-framed second floors with decorative recessed wood panels in the mullions between the windows. Both towers contained distinctive, rounded, projecting bays facing trackside on the second floor, and on the interior, both towers had internal stairways and second floor toilet rooms (see Figs. 15, 16 and 17).

At present, Bryn Mawr is used for office and storage purposes and is in good condition; Paoli, is still used to control train movements, but its bay and most of the south (trackside) elevation were demolished after a derailment, which included a horrendous crash into the building – it was rebuilt flush with the exterior wall.²⁴

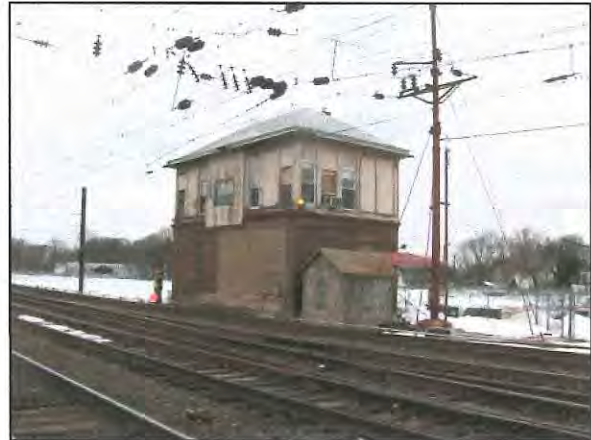
Fig. 16 (above): south (trackside) and east elevations of Paoli Tower in 2010 (photo by John R. Bowie, A.I.A.)

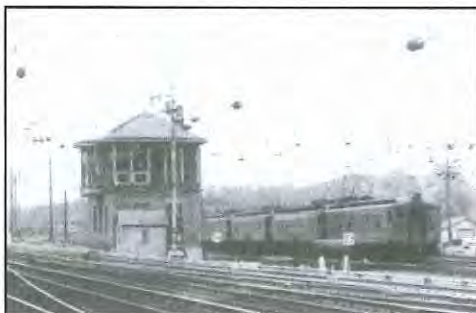
Fig. 17 (left): view of Paoli Tower, taken on June 11, 1966, before the bay was destroyed (photo copied from Triumph II, Philadelphia Terminal 1838-2000, page 205)

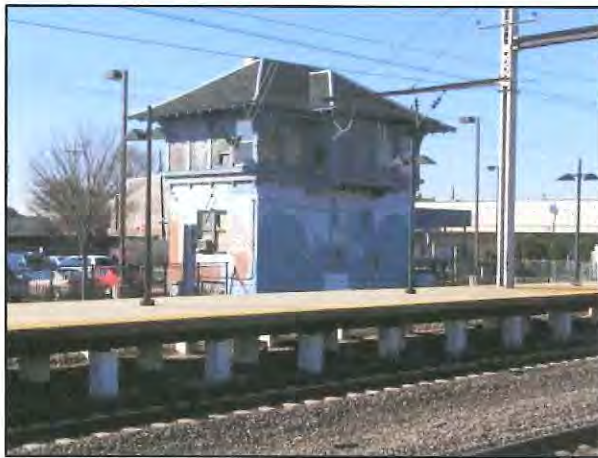
Fig. 18: north (trackside) and east elevations of North Phil Tower, Philadelphia in 2008 (*photo by J.R. Bowie*)

This second period eventually began to see several distinct types of standardized tower design begin to emerge in the PRR's Northeast Corridor. The first of these occurred between 1910-1915, just before World War I, and is readily exemplified in North Phil Tower (dated 1914), in Philadelphia. North Phil was constructed according to a prototype design also seen at Fair Tower (Trenton, New Jersey, dated 1915), Union Junction Tower (north end of Pennsylvania Station, Baltimore, dated 1910-11) and Baltimore & Potomac Tower (south end of Pennsylvania Station, Baltimore, dated 1910-11) (see Figs. 18-21).

The design of each of these towers was remarkably similar – they were all two-stories in height, with broad, overhanging hipped roofs, stucco-covered, concrete foundation/first floor walls (although Fair Tower was stucco-covered terra-cotta), wood-framed second floors containing large double-hung banks of windows facing trackside and the approach elevations, and generous amounts of Arts-&-Crafts details in the exterior brackets, cornice details and belt coursing. All of these towers contained interior second floor stairways, second floor toilet rooms, steel and concrete floor framing, and were constructed to correlate with major track and infrastructure improvements along the Northeast Corridor – Union Junction and Baltimore & Potomac when Baltimore’s impressive Pennsylvania Station was constructed, Fair when Trenton Station was constructed and North Phil when the Connecting Railroad was enlarged to six-tracks and the Chestnut Hill commuter line constructed. Each of these towers also contained US&S Model 14 electro-pneumatic switch machines on the second floor and relay banks on the first floor. North Phil is the only tower in Pennsylvania of this era to survive.²⁵

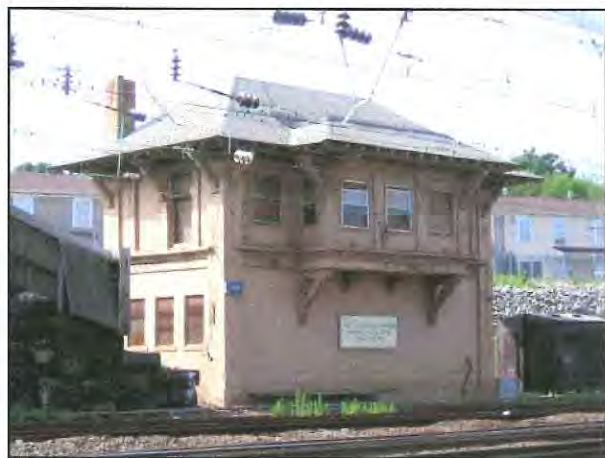
Fig. 19: north (trackside) and east elevations of Fair Tower, Trenton, in 2010 (*photo by L.A. McCrory*)

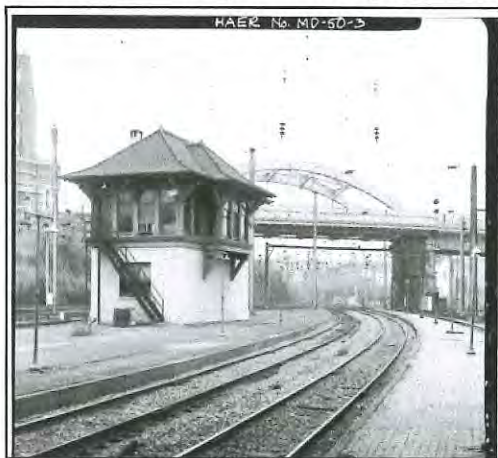
Fig. 20: north (trackside) and east elevations of Union Junction Tower in Baltimore – demolished (*photo for HAER by William Barrett, 1983 – see HAER MD-50*)

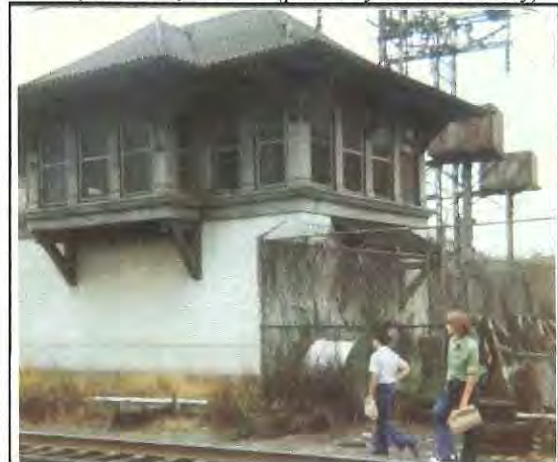
Fig. 21: north (trackside) and west elevations of Baltimore & Potomac Tower in Baltimore (*photo by S. Martin & F. Dunn, 1975 – see www.jdtowers.org*)

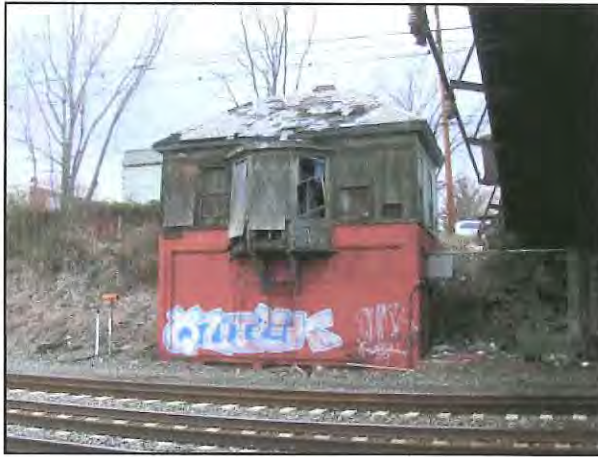
Fig. 22: east (trackside) elevation of Lamokin Tower in 2008 (photo by John R. Bowie, A.I.A.)

Another distinct standardized design type of the later second period to emerge from the PRR’s design engineers and architects was a more conservative and less-ornamented design – constructed completely of masonry (concrete or brick foundations/first floors) and brick second floors, with considerably less exterior ornamentation. Like many of the earlier towers of this period, these were two-stories in height, rectangular in plan, constructed with steel and concrete framing,²⁶ and containing internal stairways and second floor toilet rooms. Each of these towers also had a projecting second floor trackside bay and contained a US&S Model 14 switch machine to control their interlocking – Lamokin (c.1925), which controlled a full crossover and the junction with the Chester Creek Branch, Overbrook (1926), which controlled a full crossover on the Keystone Corridor, Zoo Tower (1930), a massive tower containing a 227-lever US&S Model 14 switch machine that controlled the wye where eastbound tracks to New York, westbound tracks to Harrisburg and Pittsburgh, and southbound tracks to Philadelphia’s Broad Street Station and all points south converged,²⁷ and Arsenal Tower (1932), which controlled a full six-track crossover as well as the entrance to the South Philadelphia freight yard and the wye to the High Line (an elevated viaduct that bypassed the congestion of center city Philadelphia), and the West Chester Branch. Each of these towers was remarkably similar in design, proportion and detailing, both on the exterior and the interior, and each tower employed a US&S

Model 14 electro-pneumatic switch machine. Today, each of these four towers survives intact. Lamokin and Arsenal have been heavily vandalized, and Lamokin has partially collapsed from weather infiltration associated with roof leaks (see Figs. 22 and 23). However, Zoo and Overbrook still function as operating towers controlling trains (see Figs. 24 and 25).

Lamokin Tower – overall condition: poor

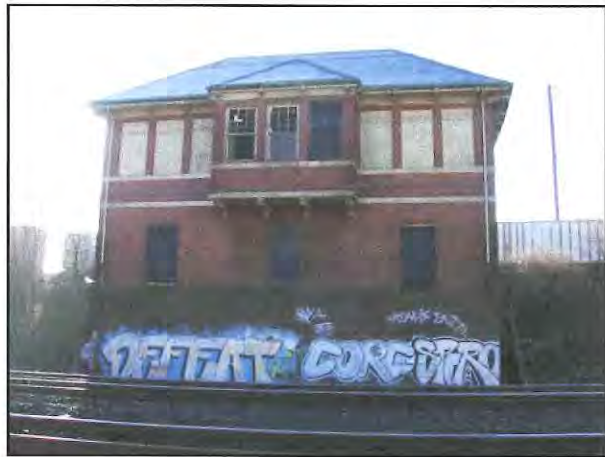
Fig. 23: east (trackside) elevation of Arsenal Tower in 2008 (photo by John R. Bowie, A.I.A.)

Arsenal Tower – overall condition: fair

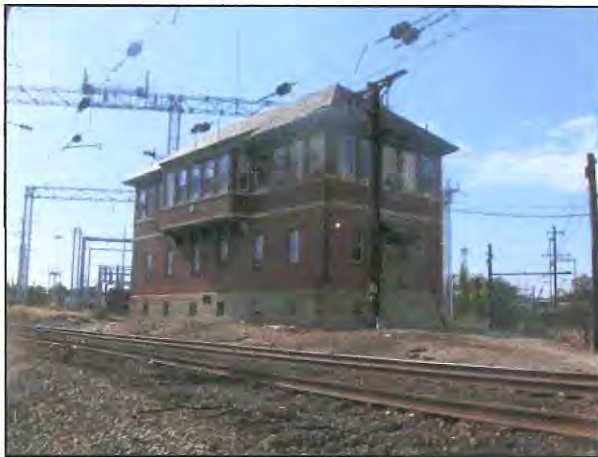
Fig. 24: east (trackside) elevation of Zoo Tower in 2009 (photo by Lou Anne McCrory, A.I.A.)

Zoo Tower – overall condition: good

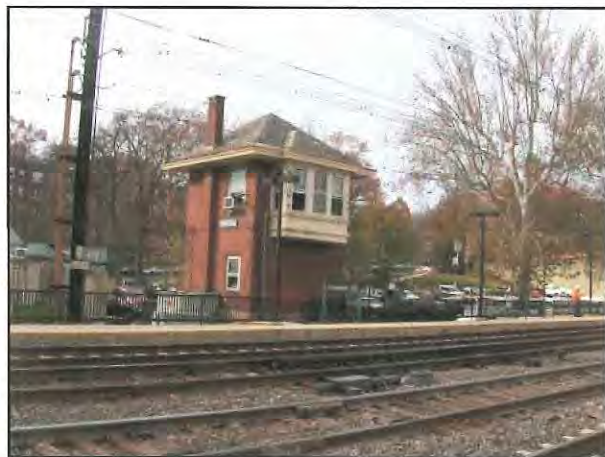
Fig. 25: north (trackside) elevation of Overbrook Tower in 2009 (photo by John R. Bowie, A.I.A.)

Overbrook Tower – overall condition: good

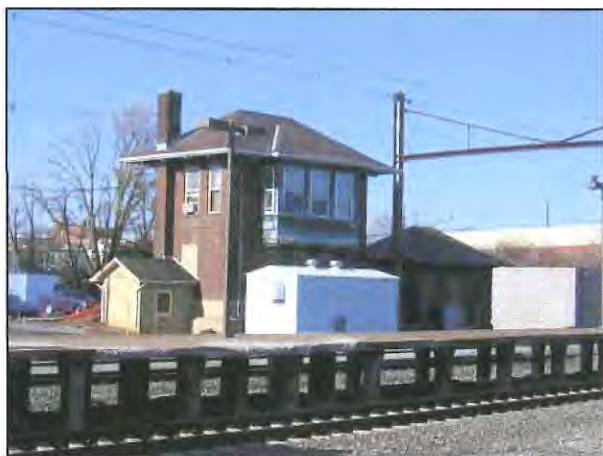
Fig. 26: north (trackside) and east elevations of Cork Tower (and adjacent compressor building, in shadow to the right) in 2009 (*photo by John R. Bowie, A.I.A.*)

because of their elegant exterior architectural details. Both towers contained recessed panels cast into the concrete foundation walls; they contain Flemish bond brickwork and projecting brick quoins on the corners, as well ornamental projecting belt courses between floors. However, they also contain copper-clad brackets at the cornices (with molded panels in the copper between the brackets), projecting copper-clad support brackets and corresponding molded panels beneath the projecting bay, and all the copper was scored and painted to resemble dressed stonework. Both towers contained interior stairways connecting the three floors; however, Cork also contained a separate single-story outbuilding of similar design and construction to house its air compressors (to power the track switches and signals). Cork is the only surviving example of this type of tower in Pennsylvania, and it continues to be operational as a working tower. Gwynn is abandoned and in an advanced state of deterioration and vandalism (see Figs. 26 and 27).

Cork Tower – overall condition: good

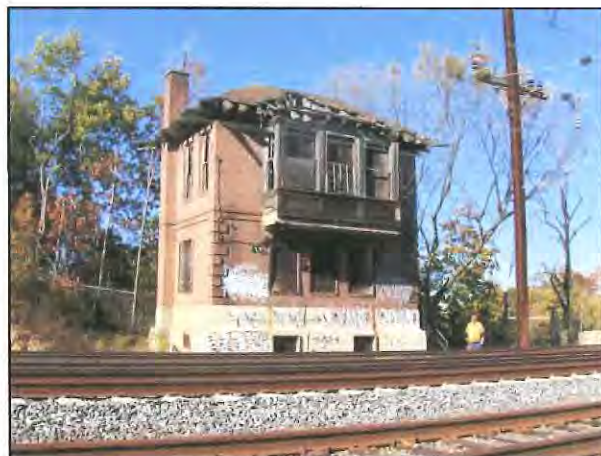
Fig. 27: east (trackside) and south elevations of Gwynn Tower in Baltimore, Maryland in 2010 (*photo by Tiegan C. Lewis*)

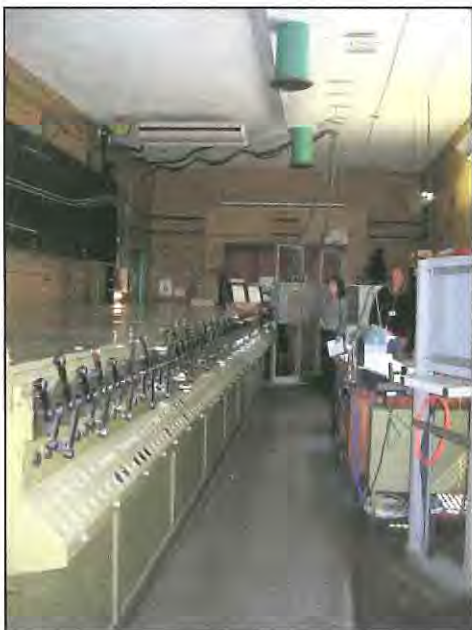
Fig. 28 (left): long view north across the interlocking control room of State Tower in 2010 (*photo by Lou Anne McCrory, A.I.A.*)

The final tower of this period in Pennsylvania is unique – the State Tower (1937) was installed on the eastern side of the second floor of Harrisburg Pennsylvania Station. The station itself was designed and constructed in 1897, with an addition built onto the east end in 1902. A fire severely damaged the station in 1904, and it was completely remodeled soon thereafter. In 1911, another addition was constructed – this time onto the west side of the building, and in 1937, when the Keystone Corridor was being electrified, a third addition was constructed – this one onto the east side of the building. The second floor contained a 127-lever US&S electro-pneumatic switch machine to control the east side of Harrisburg Station (see Fig. 28) and all the freight and passenger

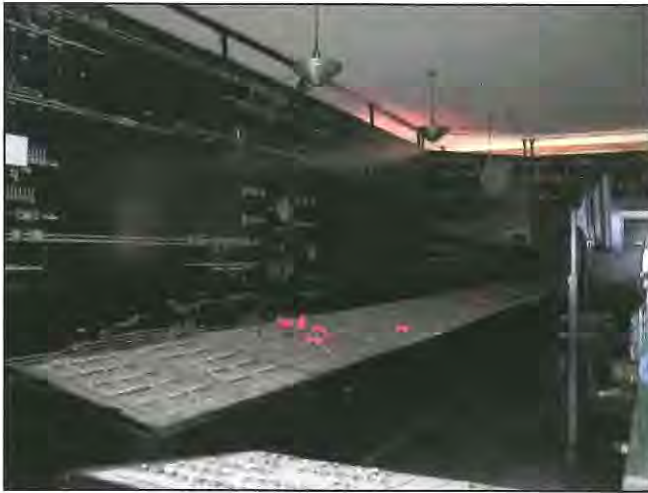
Fig. 29: long view northeast across the electric power control room at State Tower in 2010 (photo by Lou Anne McCrory, A.I.A.)

trackage to the east. The power director's office and switchboard was constructed on the fourth (directly above the switch room) (see Fig. 29).

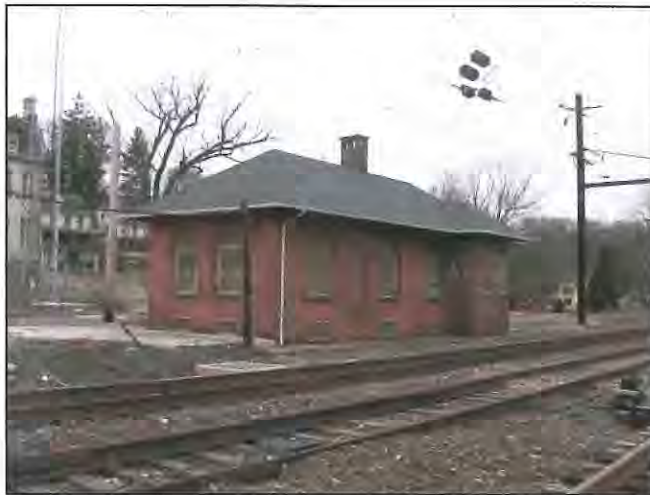
Fig. 30: south (trackside) and west elevations of Park Tower, in 2010 (photo by John R. Bowie, A.I.A.)

Six towers in Pennsylvania date to this third period. The first, Park (dating to 1937, and located in Parkesburg, Chester County at the eastern end of the high-volume duckunder freight connection with the Atglen & Susquehanna Low Grade²⁸) is an anomaly because it was installed in a single-story brick building with round-arched windows and a broadly-overhanging hipped roof. The building contains numerous infilled openings and a projecting bay, which appears to have been added at a date later than its original construction, and it is unclear whether the building was initially constructed as an interlocking tower, or if the tower functions were added to an already-existing building of an earlier era (see Fig. 30). Irrespective of the scenario, the building contains a US&S Style “P” electro-pneumatic switch machine to control the full four-track crossover which provided access to the duckunder.

Park Tower – overall condition: good

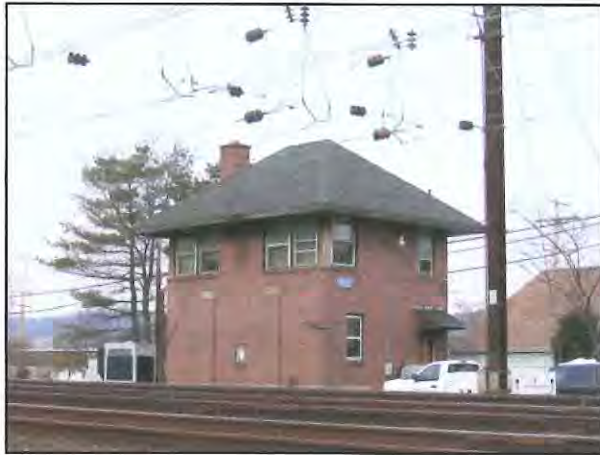
Fig. 31 (above, left): south (trackside) and east elevations of Thorn Tower, in 2010 (*photo by Lou Anne McCrory, A.I.A.*)

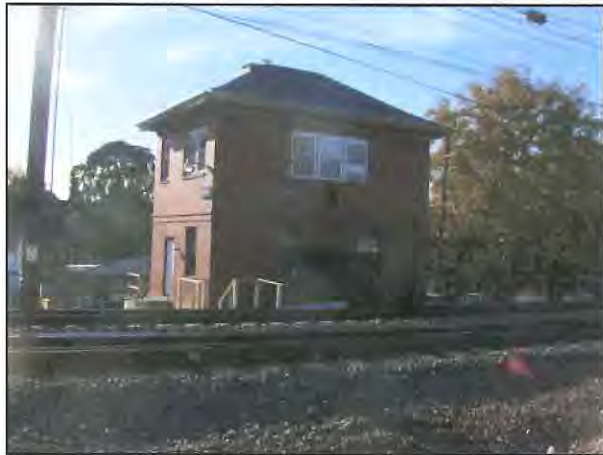
Fig. 32 (above, right): north (trackside) and east elevations of Morris Tower, in 2009 (*photo by John R. Bowie, A.I.A.*)

Morris Tower – overall condition: good

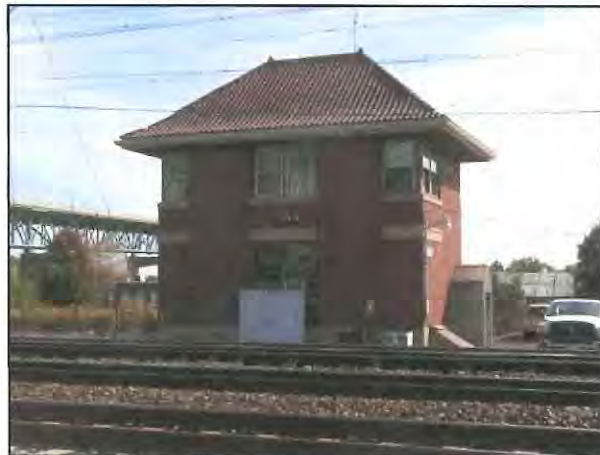
Fig. 33 (left): north (trackside) and west elevations of Grundy Tower, in 2009 (*photo by John R. Bowie, A.I.A.*)

provide the duckunder for the Morrisville freight yard and the Trenton Cut-Off. Finally, Grundy Tower was located near Bristol, Bucks County, and provided a full four-track crossover to access the Bristol Old Line and several local industrial sidings (see Figs. 31, 32 and 33).³⁰

Towers, in Princeton Junction and Monmouth Junction, NJ, respectively, contained design elements that made it resemble Frank Lloyd Wright's early Prairie-style houses of the early-20th century – see Figs. 34 and 35).³² Grundy's trackside facade contained slightly projecting brick masses that flanked the center bay of windows and were incised by the horizontal lines of the concrete belt courses at the second floor level. All three towers contained US&S Model 14 electro-pneumatic switch machines; however, Thorn was upgraded to contain an all-electric CTC switch machine when this portion of the Keystone Corridor's operations were consolidated into Thorn Tower to control the former Glen, Dale and Caln and Downes interlockings, as well as Thorn itself.

Grundy Tower – overall condition: good

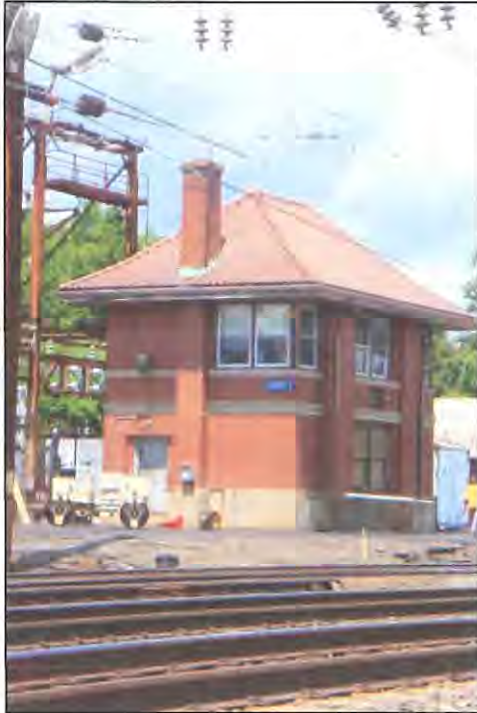
Fig. 34 (left): south (trackside) and west elevations of Midway Tower, Monmouth Junction, NJ, in 2010; note its similarity to Grundy Tower (seen in Fig. 33) (*photo by Tiegan C. Lewis*)

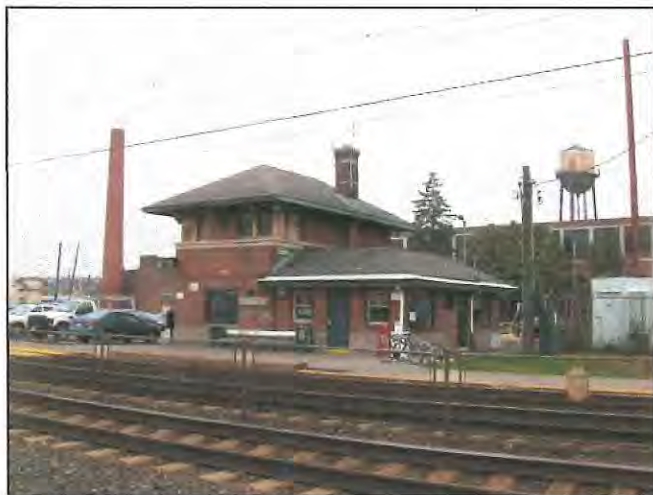
Fig. 36: south (trackside) and east elevations of Holmesburg Station/Tower in 2010 (the SEPTA station is the single-story portion of the building, to the right) (photo by John R. Bowie, A.I.A.)

Holmesburg Station/Tower, also dating to 1947, provided a variation on the design of this third period of PRR tower design. At Holmesburg, the two-story tower controlled a full four-track crossover, as well as the junction with the Bustleton Branch, a local freight line that served industries in that part of Philadelphia. However, a one-story wing was placed onto the east side for the Holmesburg PRR commuter rail station (now SEPTA, and currently in daily use). The tower contained a US&S Model 14 switch machine, and its layout and design were the same as other towers of the period (see Fig. 36 – next page).

Holmes Tower/Station – overall condition: good

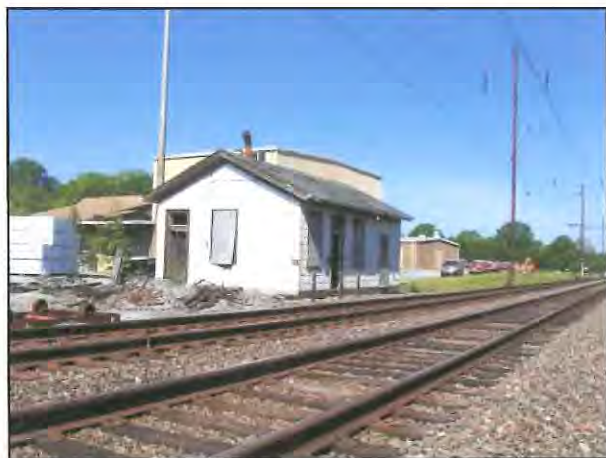
Fig. 37: north (trackside) and east elevations of Landisville Block Station in 2008 (photo by John R. Bowie, A.I.A.)

The Landisville Block Station was non-descript with a shallow gable roof parallel to the PRR tracks, and clad in asbestos siding (which appears to be original), and it contained hold-over eclectic detailing such as the shallow-arched, double freight door and the four-panel office door with transom. The western room was the freight station containing a wood floor and plaster walls and ceiling, and the eastern room was the block operator's office containing a small vestibule, wood floors and wood bead-board wainscot with plaster walls (above) and a plaster ceiling. The office contained a cast-iron stove and a two-person desk. It also contained a US&S timer-controlled switch machine that the block operator manually operated to control the interlocking (see Figs. 37 and 38).³⁴

Landisville Block Station – overall condition: fair

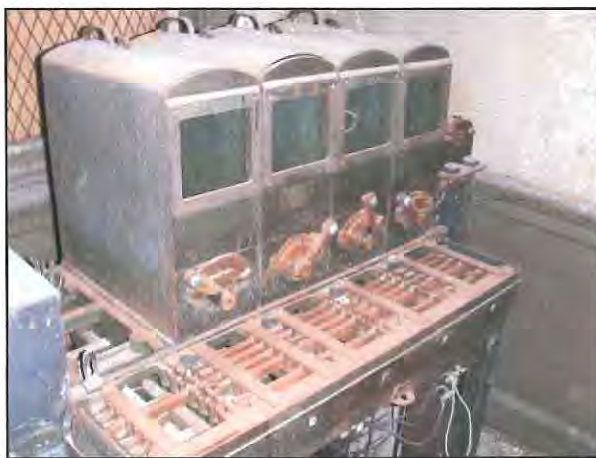
Fig. 38: detail of US&S switch machine at Landisville Block Station (photo by John R. Bowie, A.I.A.)

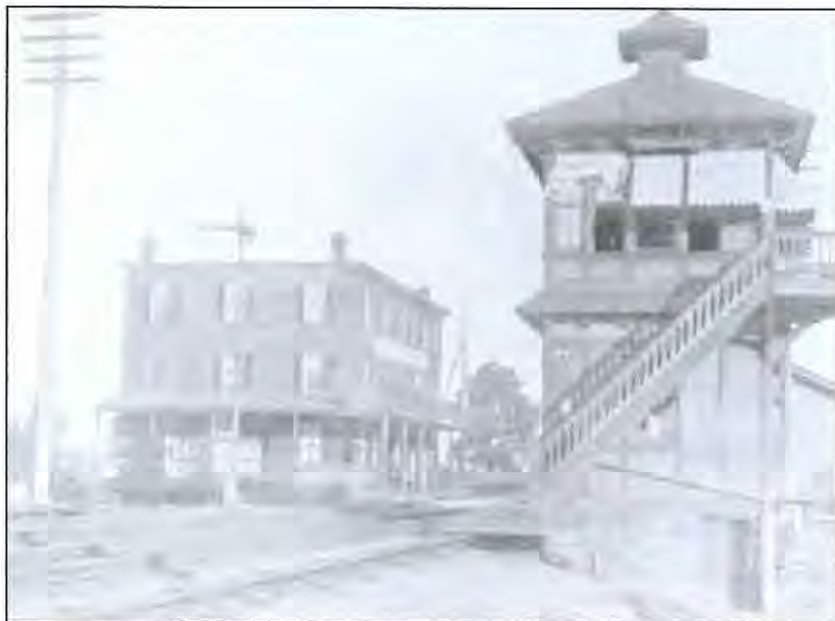
Fig. 39: copy of 1909 photo of the original Landis Tower/station (with railroad hotel in background), taken from *Triumph II Philadelphia to Harrisburg 1828-1998*, page 190. There are slight discrepancies between the 1909 date for this photograph and the 1904 date that the second Landisville Block Station was constructed. It is possible the 1904 date indicated in the drawing refers exclusively to the switch machine itself, which could have been originally installed in the tower/station and then relocated to the single-story building when the tower was demolished.

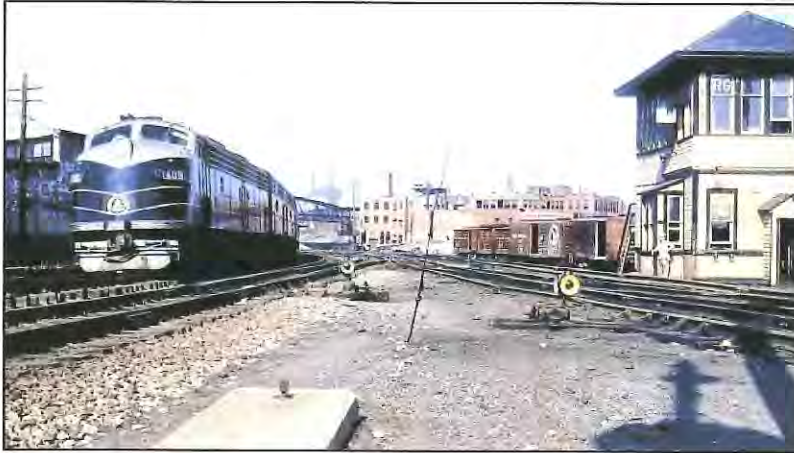
Fig. 40: 1958 photo showing the B&O's first RG Tower in Philadelphia, taken from Greg Reynolds and Dave Oroszi's excellent *Baltimore & Ohio Railroad* (MBI Railroad Color History), pg. 66.

PW&B for 98 miles all the way to Baltimore.³⁷ RG Tower was a two-story, wood frame building that controlled the B&O's trackage in Philadelphia east of the Schuylkill (see Fig. 40). It was replaced in 1960 with a modern office tower as part of a B&O modernization project, and it subsequently closed in 1996.³⁸

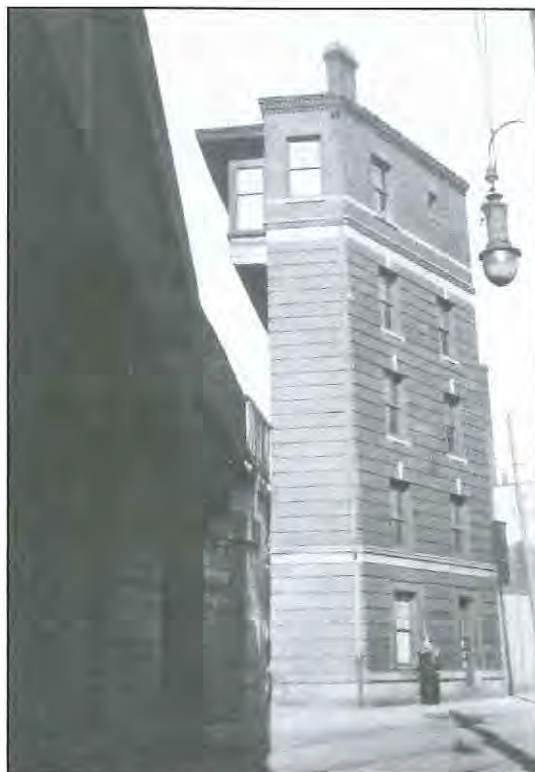
Fig. 45: Diamond Street Tower, wedge-shaped tower on west side of 9th Street Viaduct leading to Reading Terminal, taken from Holton (page 285)

Another unusually-shaped tower on the Reading line was the Diamond Street Tower, located in a narrow wedge-shaped lot at the base of the 9th Street Viaduct (where the tracks were elevated approaching Reading Terminal in Philadelphia (see Fig. 45, next page). The building was fit into a tight footprint and raised up four stories in order for the tower operator to have a good view of approaching trains on the viaduct. The building was brick, with recessed horizontal scribing to give the appearance of rustication. The fifth floor tower also contained a projecting

bay that provided the operator with an unobstructed view of the tracks. The tower was destroyed by a fire on New Years Day 1963.
