150005 – Marion Elementary School

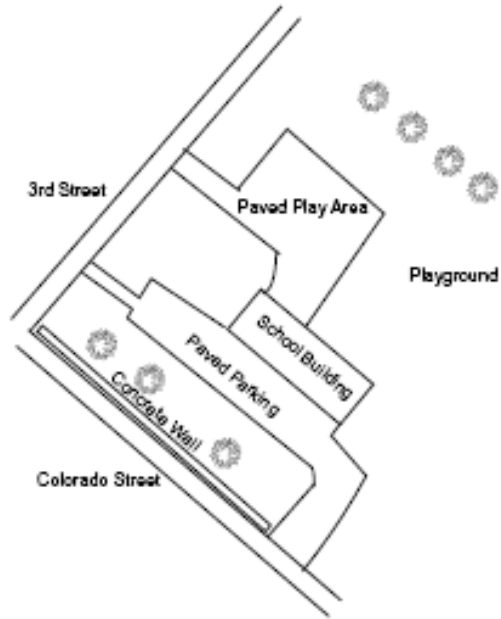
Site Plan of Marion Elementary

150005; Marion Elementary School. This school is located at 145 Colorado Street, Marion, Pennsylvania, in Guilford Township, Franklin County. It is part of the Chambersburg Area School District. The ca. 1908 school sits on a small lot at the corner of Colorado and 3rd Streets. The school building is set back from Colorado Street behind a paved parking lot and a wide swath of lawn with scattered trees. A paved play area and playground equipment surrounded by a lawn are located at the rear of the building and the lot. The front lawn features scattered trees and bushes. A low concrete retaining wall along the front of the property runs along Colorado Street. A circular pier engraved with "1908" is located at the end of the wall. A small parking lot is located at the southwest corner of the school. The walkways are concrete. The paved play area features a basketball court. The swings in the playground date to ca. 1957. Additional playground equipment is from a later period.

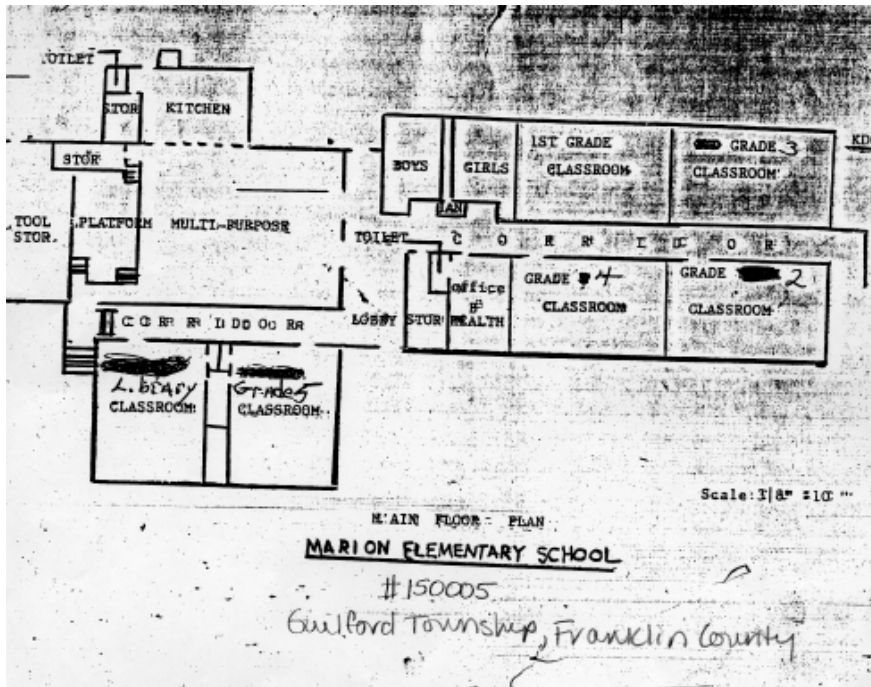
Floor Plan of Marion Elementary

The one-story school building is comprised of two main sections. The original rectangular school building was constructed with two classrooms and a rear hallway. An extensive addition constructed in 1957 added a full wing, a multi-purpose room, and a kitchen. The original school is a frame-reinforced structure with brick walls. The building sits on a stone foundation. Asphalt shingles cover the hipped roof, which features exposed rafters. An original entrance, located in a hipped side vestibule area, is a double set of pane-and-panel wood doors. The entrance is sheltered by an extension of the vestibule roof, supported by chamfered posts. The building is lit by six-over-six double-hung wood windows with slab sills and lintels. The 1957 addition to the school includes a large multi-purpose room with a kitchen at the rear of the original school building. The combination cafeteria/auditorium/gymnasium has access to the kitchen and stage. The current main entrance to the school and lobby connects the multi-purpose room and original school building to a 1957 one-story wing containing classroom and office space, and bathrooms. The addition reflects the original building in that it is a frame structure with brick walls lit by six-over-six double-hung wood windows. A portable one-story kindergarten room was appended to the eastern corner of the school ca. 1970.

The corridor at the rear of the original school building features a tile floor, a dropped ceiling with acoustic ceiling tile, fluorescent lighting, and a trap door to a cellar. Doors to the two classrooms are pane-and-panel with multi-pane transoms. The classrooms feature acoustic ceiling tile, fluorescent lighting, coatrooms, and decorative molding incorporated into bulletin board/chalkboard space. One classroom has been converted into the school library. The library floor is carpeted.
